DDESS Facility Transfer Study Facility Condition Report (Final)

Fort Benning, Georgia

December 10, 2003

FORT BENNING SCHOOLS
FORT BENNING, GEORGIA
PROPERTY CONDITION REPORT

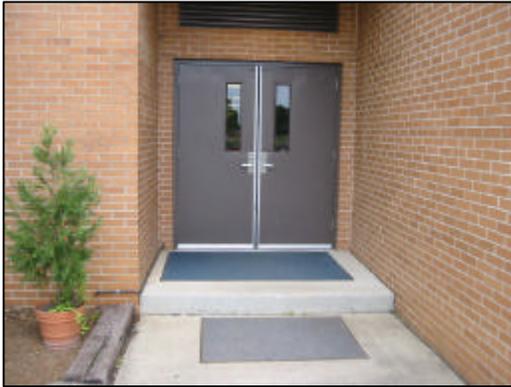
ADA Non-compliant Exit

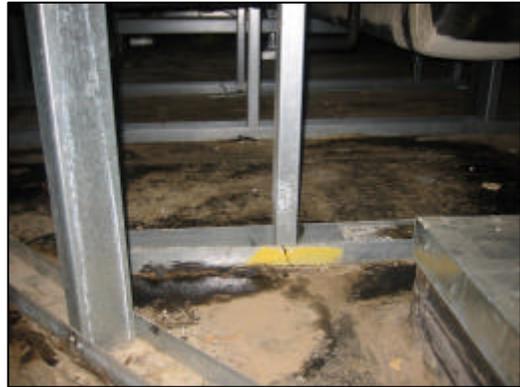
Roof Leak

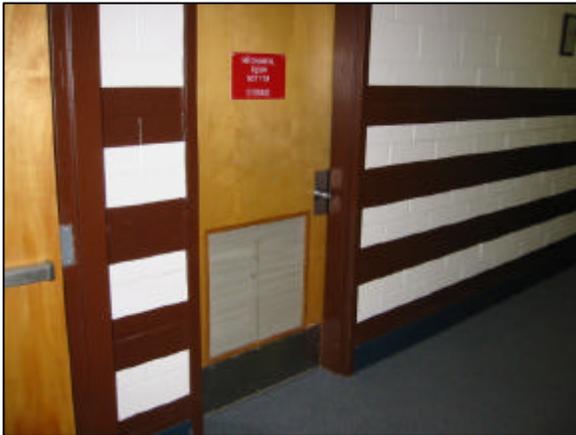
Life Safety Issue

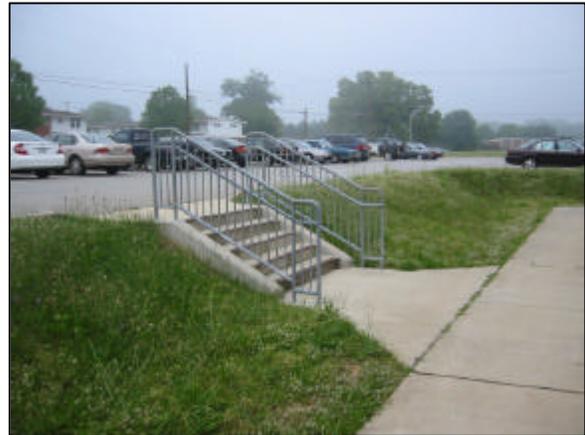
ADA Access Problem

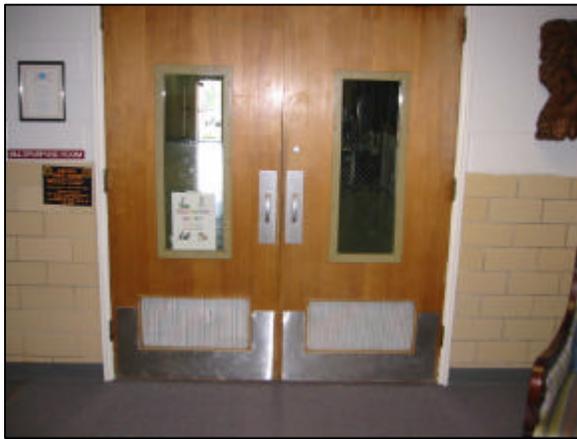
Non Life Safety Compliant Doors

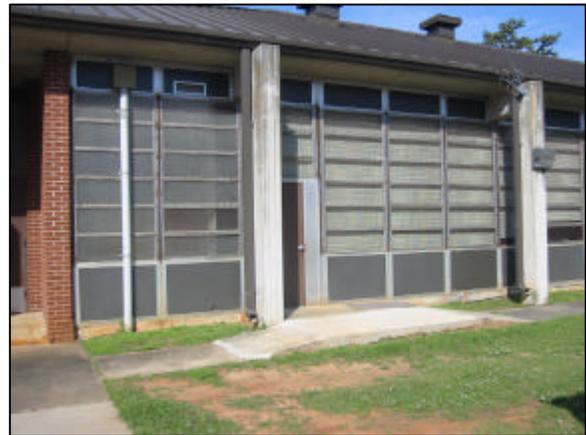
Windows in Poor Condition

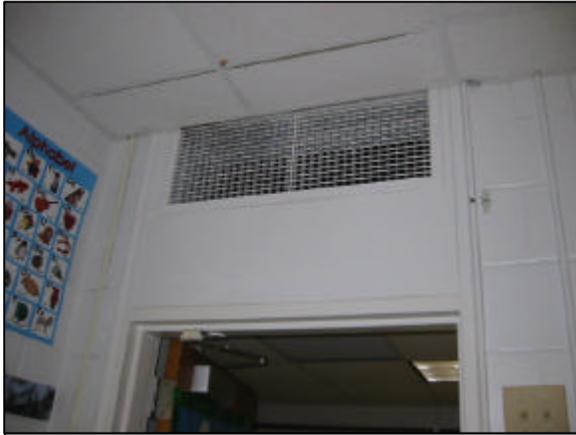
Life Safety Corridor Problem

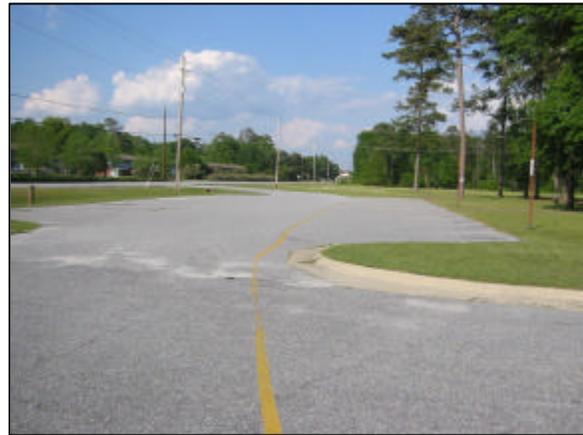
Current Undersized Bus Drop

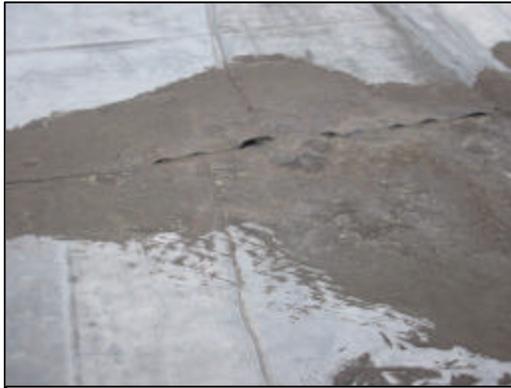
Damaged Roof Membrane

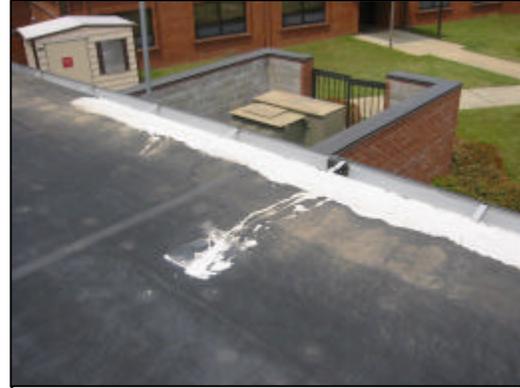
Damaged Roof Edge

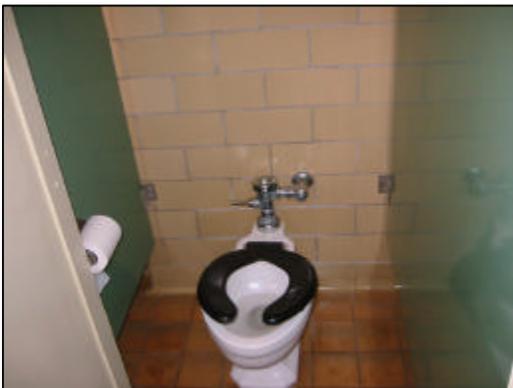
Non-compliant Toilet

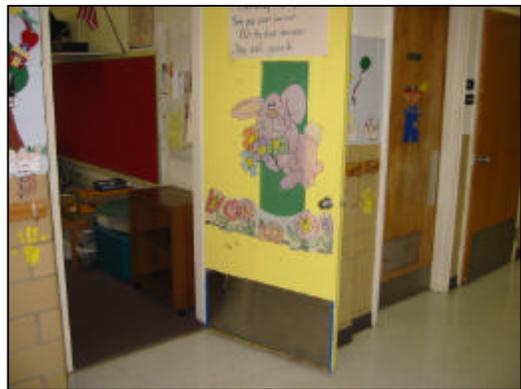
Non-compliant Exit Door

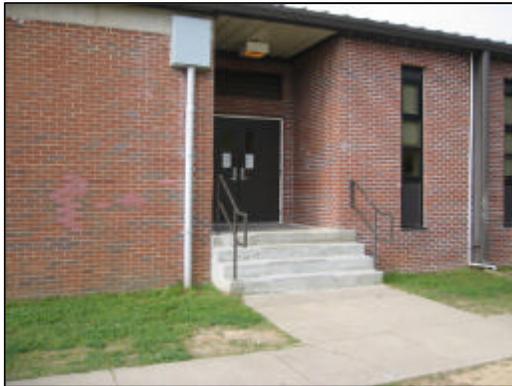
Non-accessible Exit

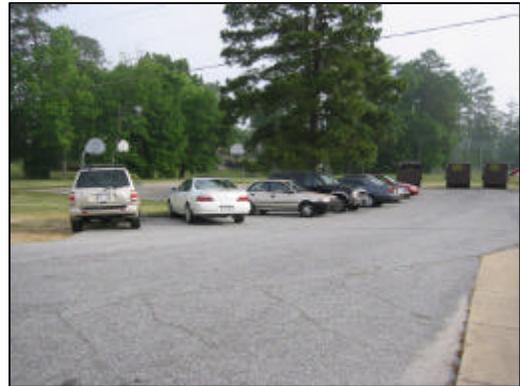
Pavement Repair Needed

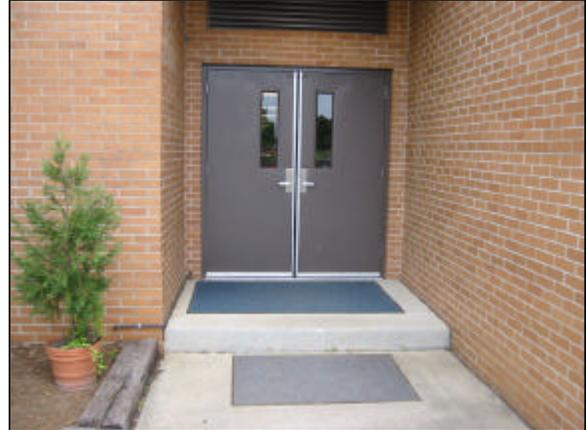
Photo 2: ADA Non-compliant Exit

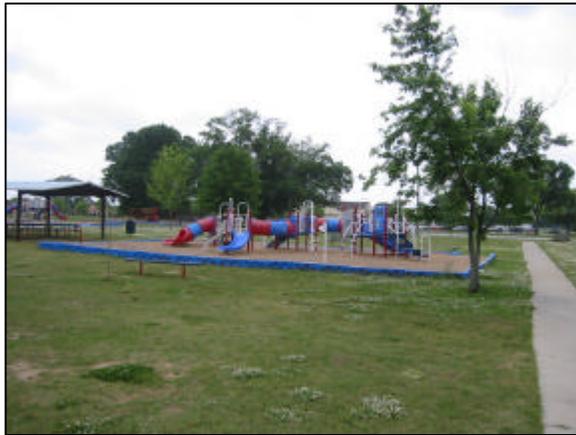
Photo 3: ADA Non-compliant Play Area

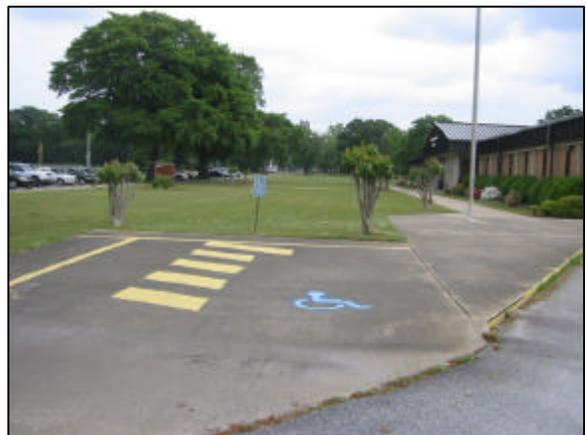
Photo 4: ADA Non-compliant Parking

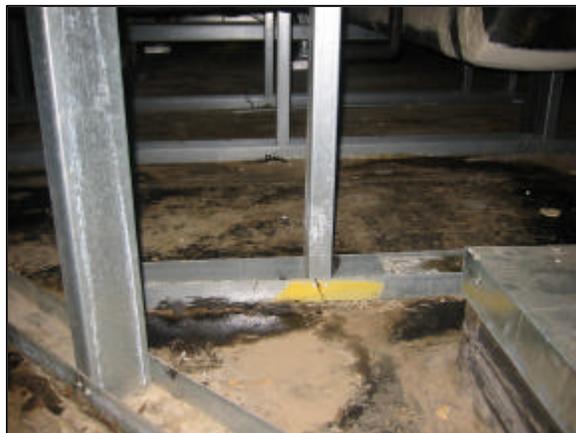
Photo 5: Roof Leak

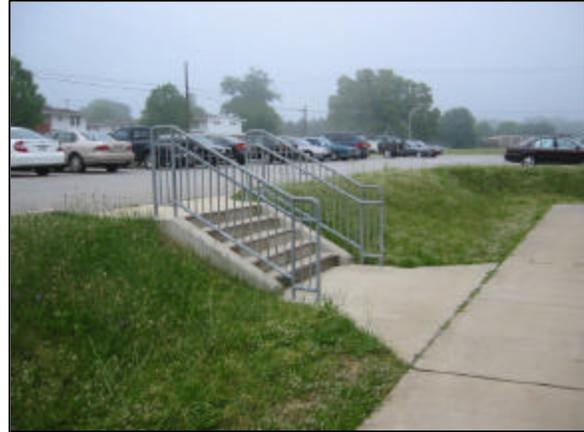
Photo 2: ADA Access Problem from Parking

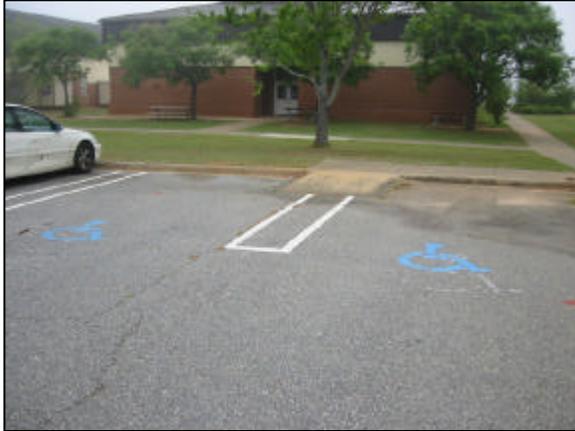
Photo 3: ADA Non-compliant Parking

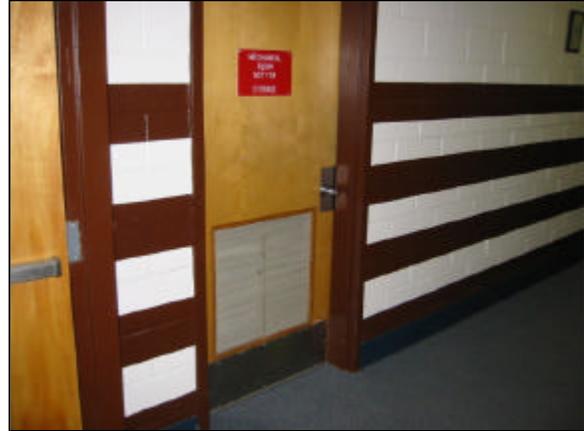
Photo 4: Life Safety Door Issue

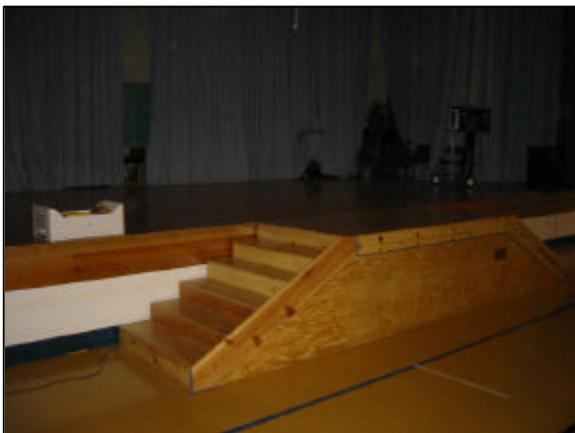
Photo 5: ADA Stage Access

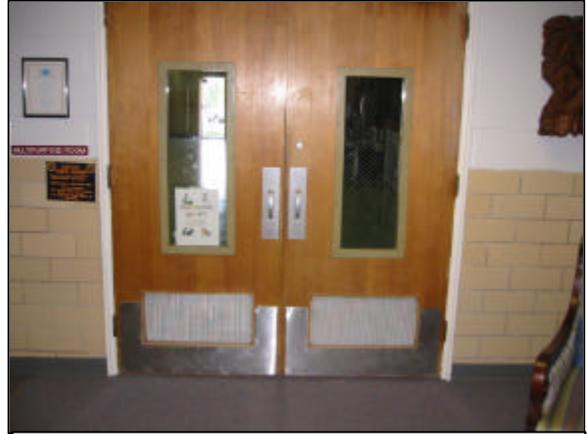
Photo 2: Non Life Safety Compliant Doors

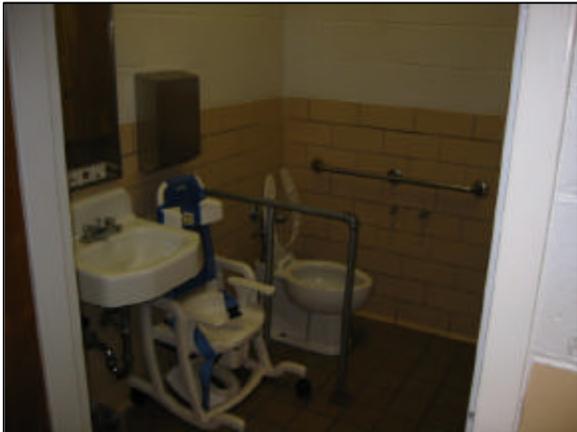
Photo 3: ADA Non-compliant Toilet

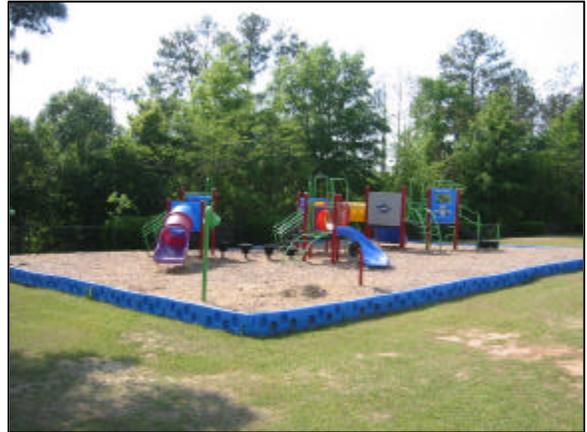
Photo 4: ADA Non-compliant Play Group

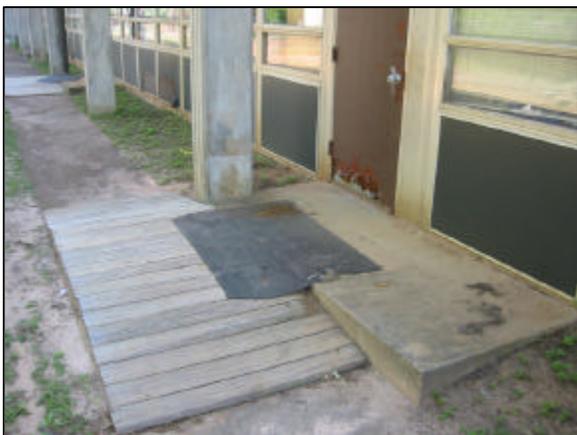
Photo 5: Rusted Door

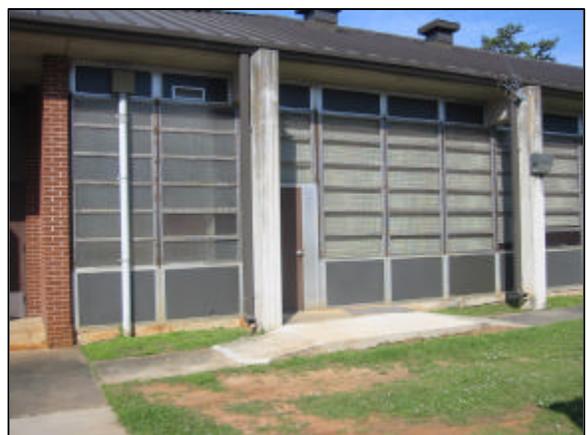
Photo 6: Old Windows

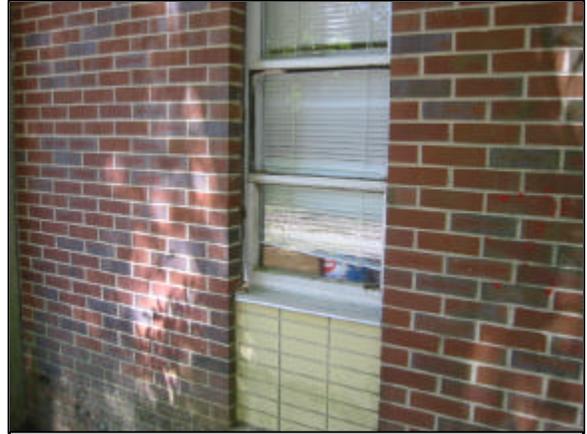
Photo 2: Non Life Safety Compliant Exit

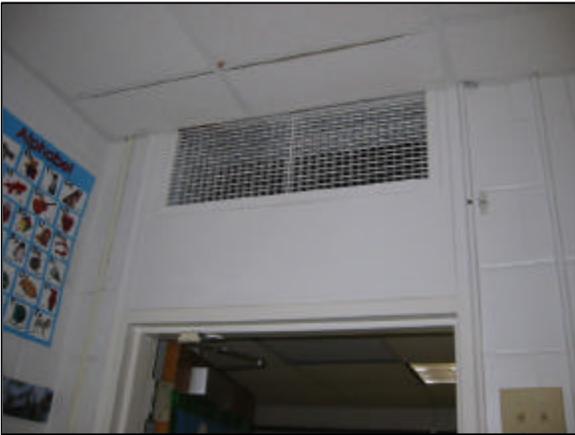
Photo 3: Life Safety Problem, Corridor

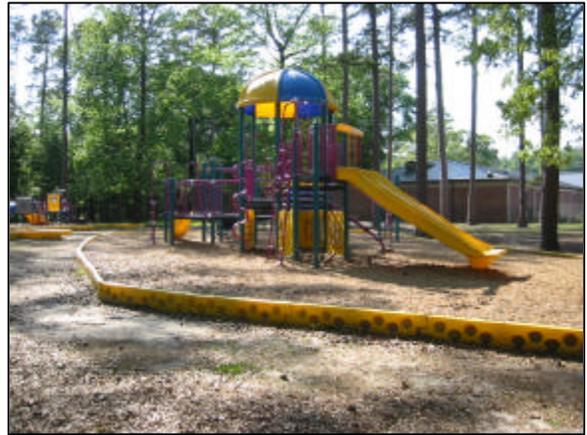
Photo 4: Non-accessible Play Surface

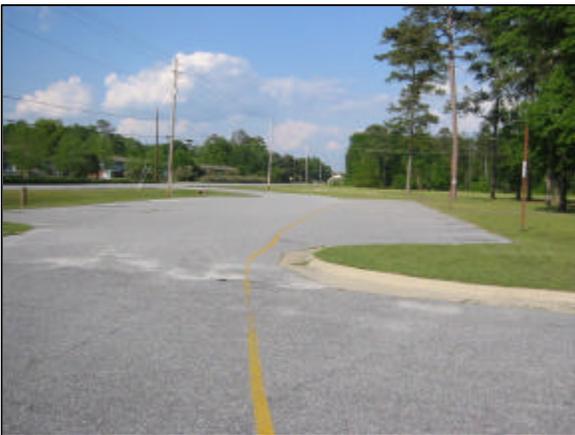
Photo 5: Existing Bus Drop

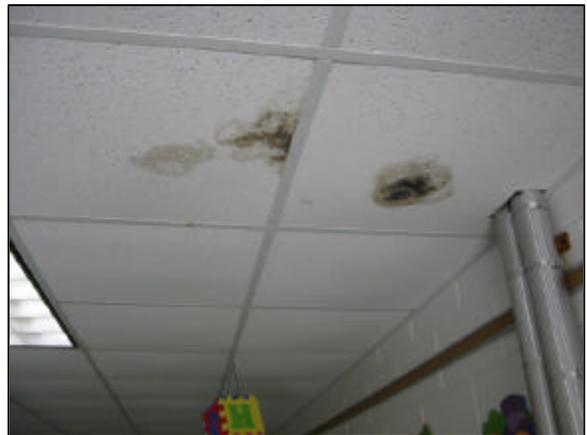
Photo 6: Roof Leak

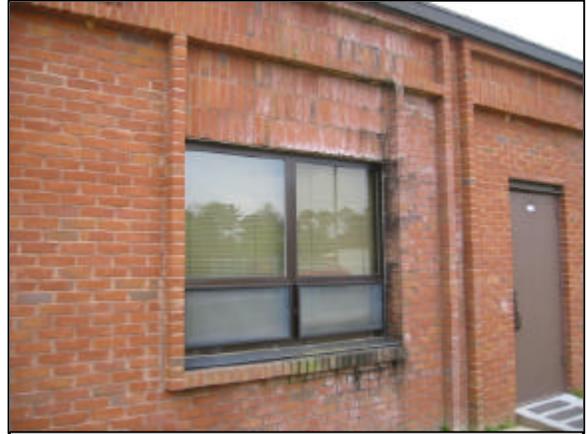
Photo 2: Masonry Water Damage

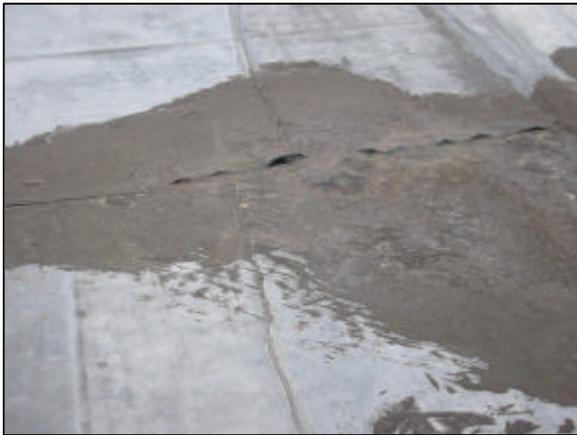
Photo 3: Damaged Roof Membrane

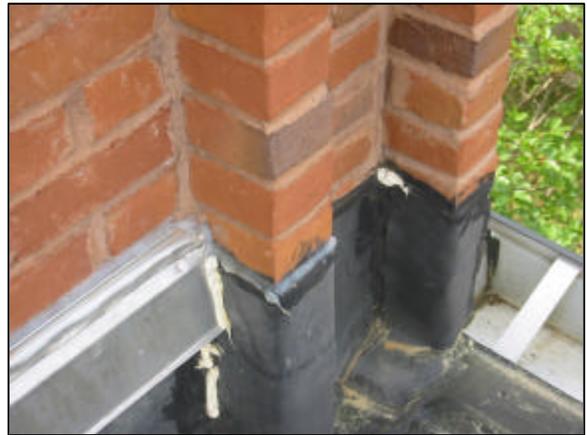
Photo 5: Patched Roof Flashing

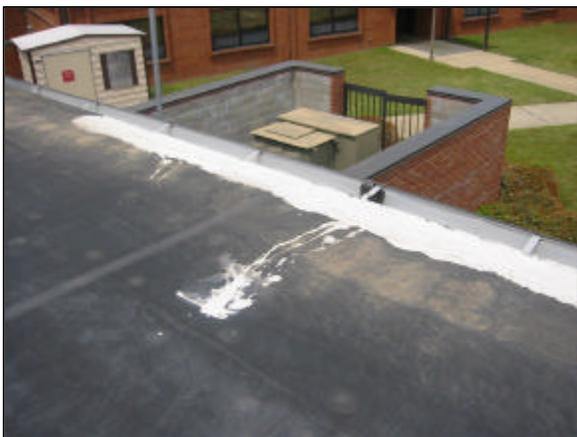
Photo 5: Damaged Roof Edge

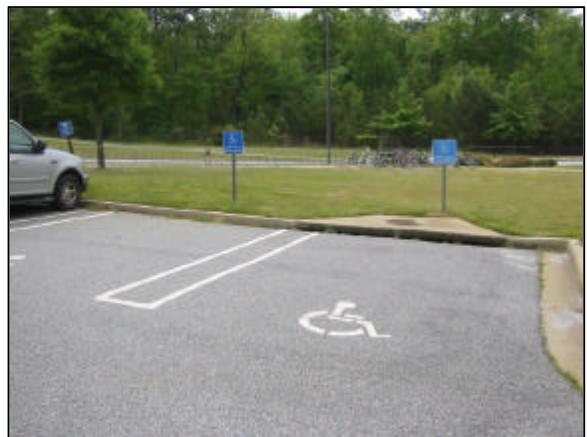
Photo 6: ADA Non-compliant Access Thru Traffic

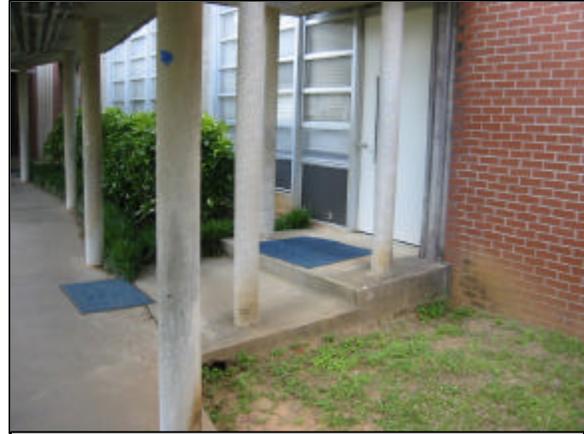
Photo 2: Life Safety/ADA Non-compliant Secondary Exit

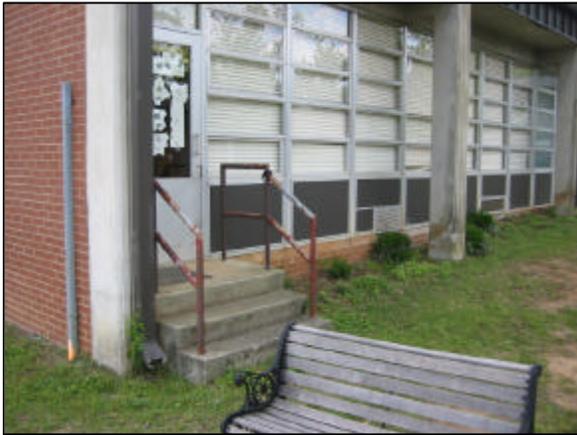
Photo 3: Non-compliant Exit

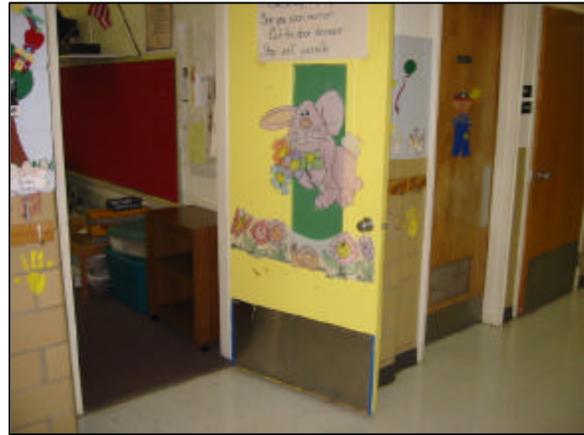
Photo 4: Non-compliant Door Hardware

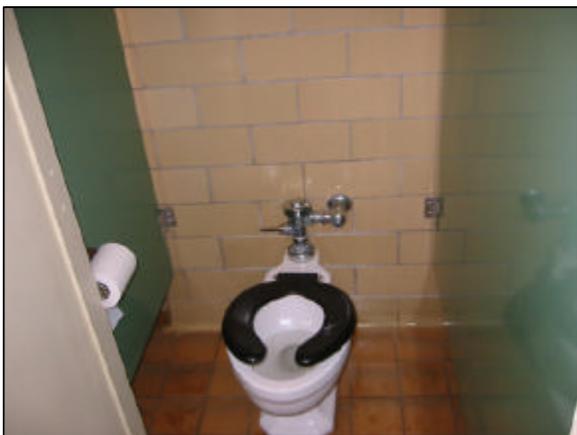
Photo 5: ADA Non-compliant Toilet

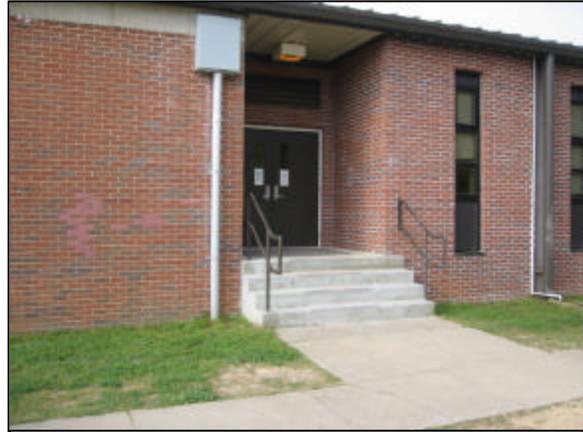
Photo 2: Non-compliant Exit

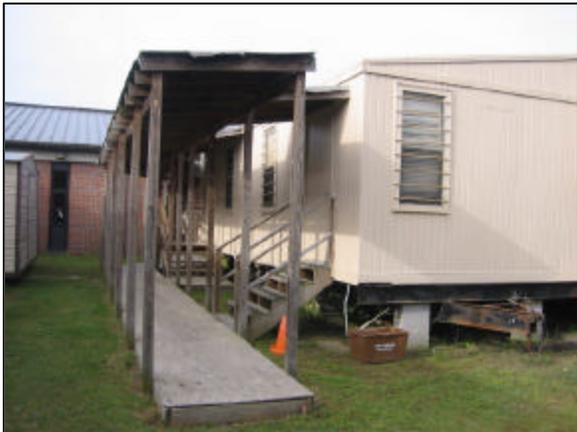
Photo 3: ADA Non-compliant Route

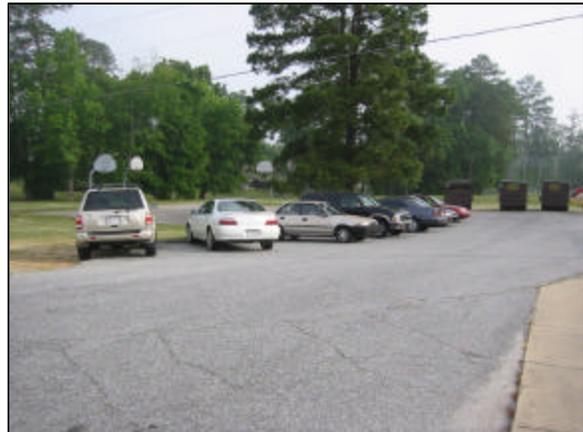
Photo 4: Pavement Repair Needed

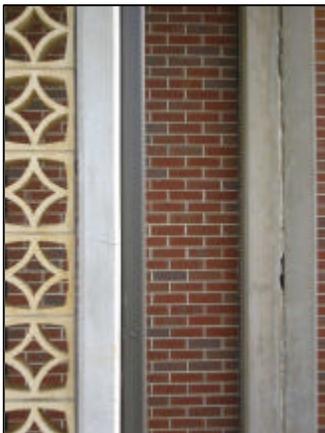
Photo 5: Concrete Column Repair Needed

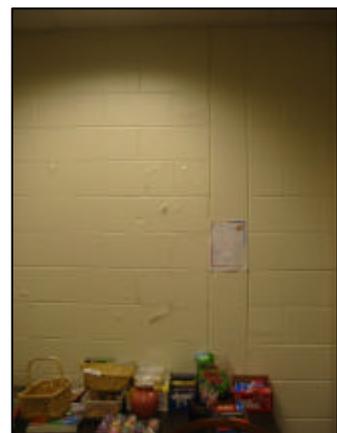
Photo 6: Moisture in Wall Cavity
