DDESS Facility Transfer Study Facility Condition Report (Final)

Maxwell Air Force Base, Alabama

December 10, 2003

**MAXWELL AIR FORCE BASE, ALABAMA
MAXWELL ELEMENTARY SCHOOL
PROPERTY CONDITION REPORT**

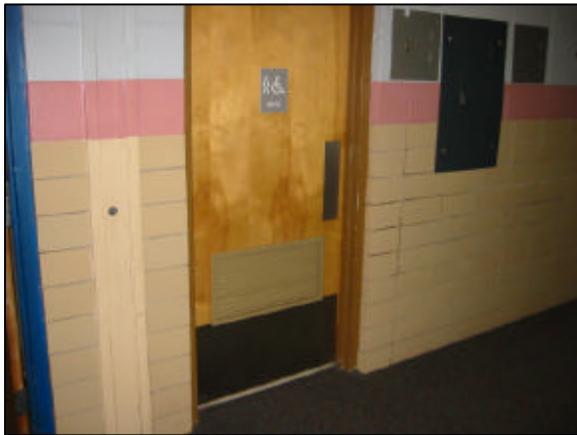
Life Safety Non-compliant Louvered Door

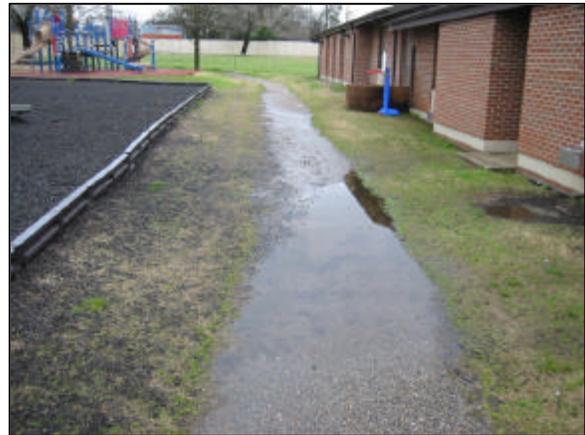
Site Drainage Problem

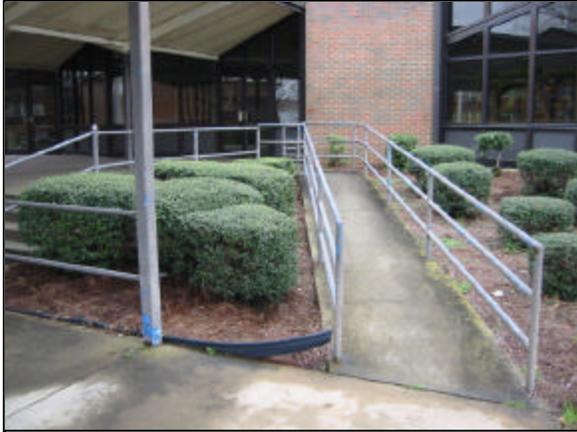
Photo 1: ADA Non-compliant Ramp

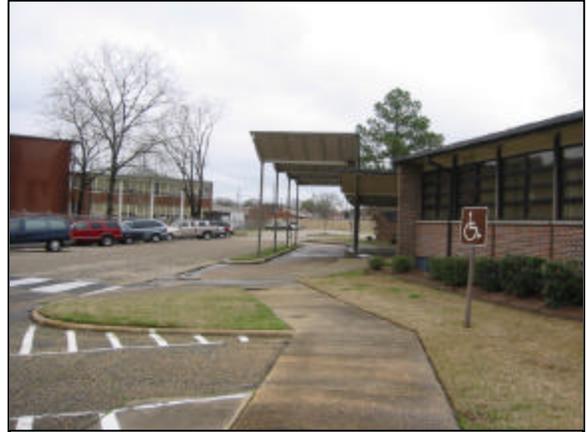
Photo 2: ADA Non-compliant Parking

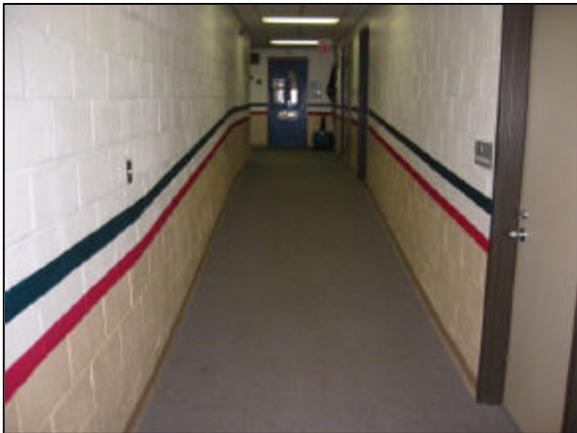
Photo 3: ADA Non-compliant Interior Ramp

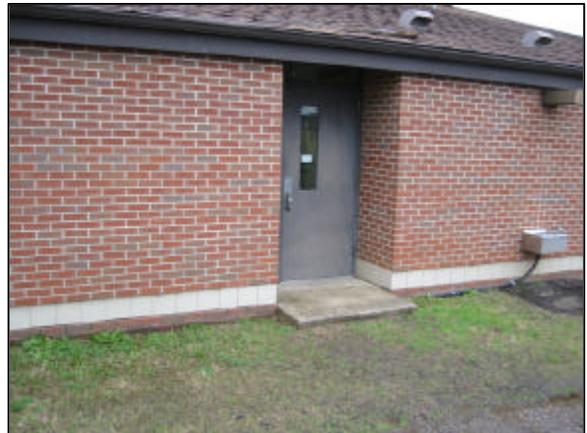
Photo 4: ADA Non-compliant Exit/Entrance

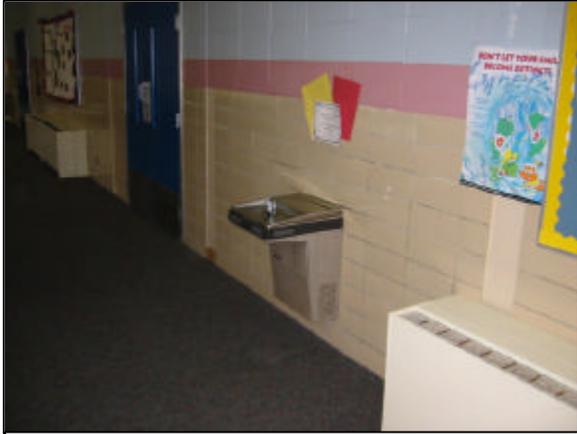
Photo 5: ADA Non-compliant Drinking Fountain

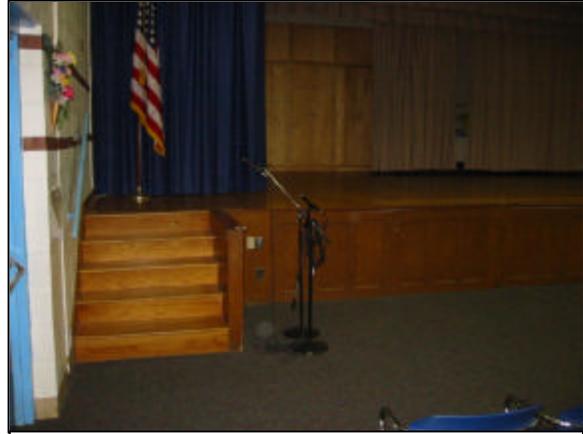
Photo 6: ADA Non-compliant Stage Access

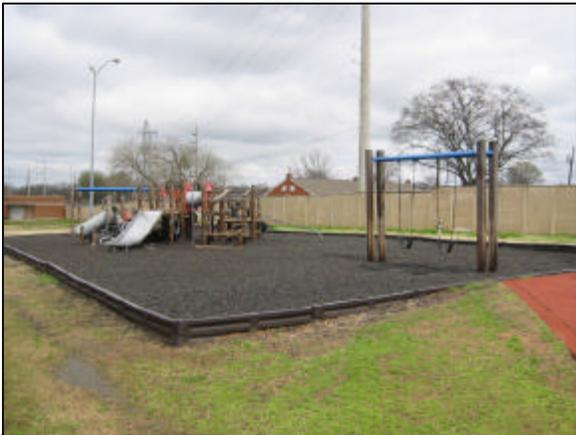
I	LT	Reference
		3.2.4 Recreational Facilities and Title IX Compliance
		<p>The school does not sponsor specific team sport programs and does appear to be in compliance with Title IX regulations. Corrective action is not required.</p> <p>Play fields for boys' and girls' field sports are available on-site and are in good condition. Corrective action is not required.</p> <p>A gymnasium provides indoor court sport recreational and assembly space. Equal toilet facilities are available for boys and girls. Corrective action is not required.</p> <p>X Play areas are provided with various types of equipment in fair condition. Corrective action is required to replace worn out equipment.</p> <p>The equipment is old, wooden, and needs sanding frequently to prevent splinters. It is a continual maintenance problem. In addition, some of the existing playground surfacing is peeling and could cause tripping problems.</p> <p>X Play surfaces are in good condition. Play surfaces in some areas do not appear to comply with the U.S. Consumer Product Safety Commission "Handbook for Public Playground Safety" requirements. Corrective action is required.</p>

Photo 7: ADA Non-compliant CPSC Wood Play Equipment

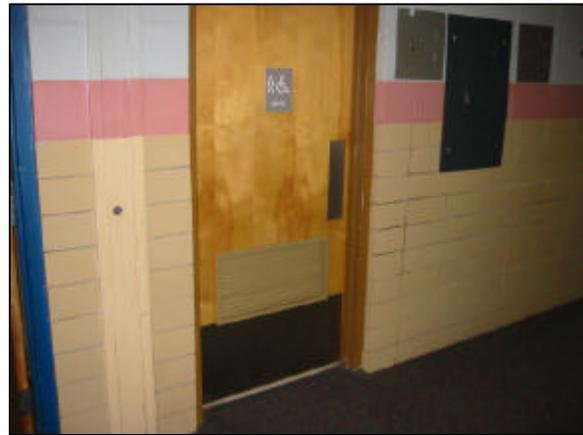
Photo 8: Life Safety Non-compliant Louvered Door

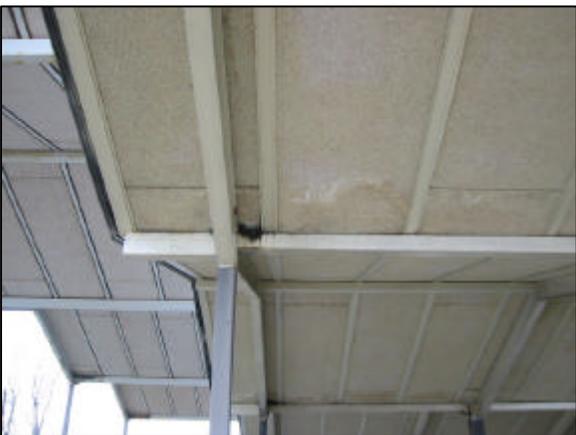
3.3.4 Roofing
	X	<p>Low slope ballasted EPDM roofing is located on the classroom areas of Building "A" and is in poor condition. Numerous leaks are evident. Corrective action is currently underway to repair these leaks although it will not be a permanent fix. Within next ten years, it is anticipated that this roof will require replacement. In fact, a roof replacement design was performed five years ago but never constructed. The costs shown in this report are for a ballasted EPDM system.</p> <p>Sloped composition shingle roofing is located on Buildings "B" and "C" and is in fair to poor condition, respectively. Shingles at wing "C" are curling, brittle and deteriorating. Leaks are evident in wing "C." Corrective action is required in wing "C."</p> <p>Flashing, coping, fascia, gutters and downspouts are pre-finished metal in fair condition. Corrective action is required when composition roofing is replaced.</p>

Photo 9: Roof Leak at Building "A" Canopy

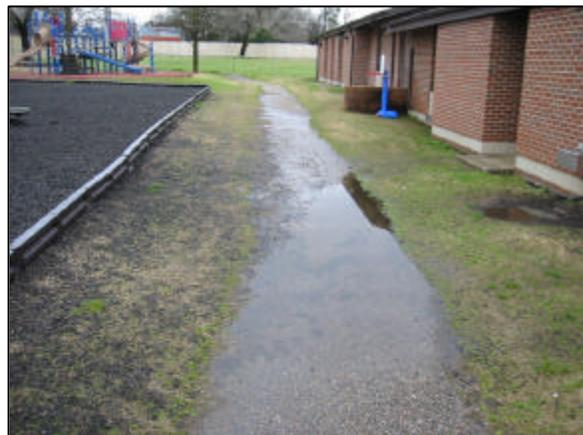
Photo 10: Site Drainage Problem
