DDESS Facility Transfer Study Facility Condition Report (Final)

Fort Knox, Kentucky

December 10, 2003

FORT KNOX SCHOOLS
FORT KNOX, KENTUCKY
PROPERTY CONDITION REPORT

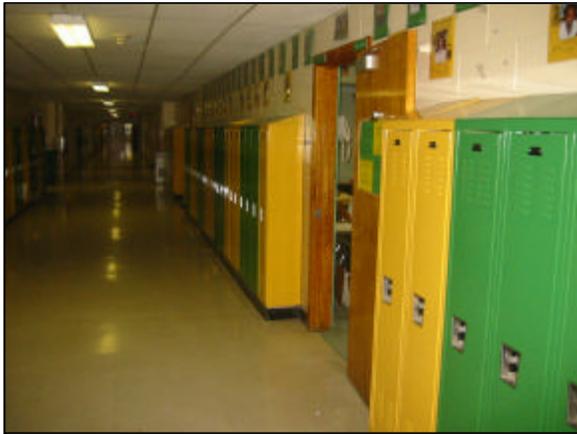
Poor Lighting in Corridor

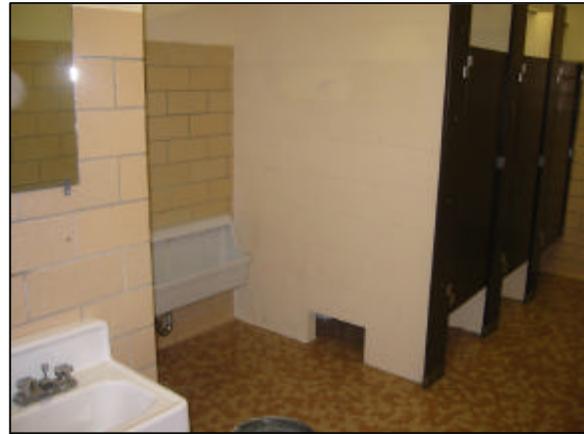
Non-compliant Restroom

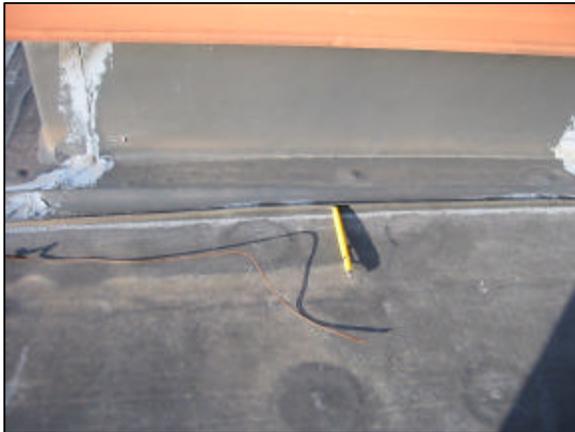
Flashing Problem

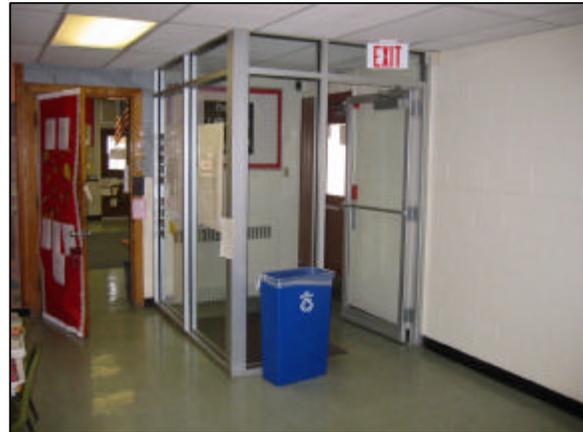
Non-Life Safety Compliant Vestibule

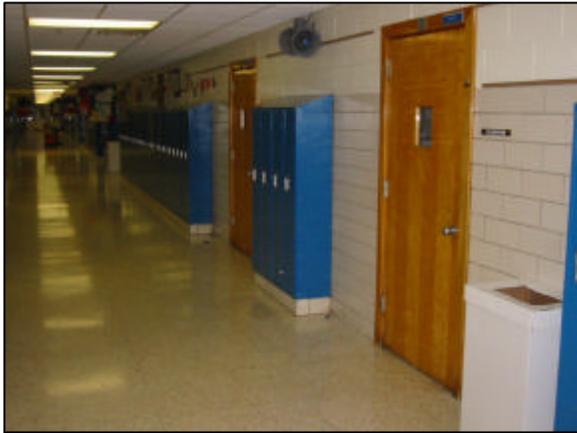
Typical Non-compliant Door

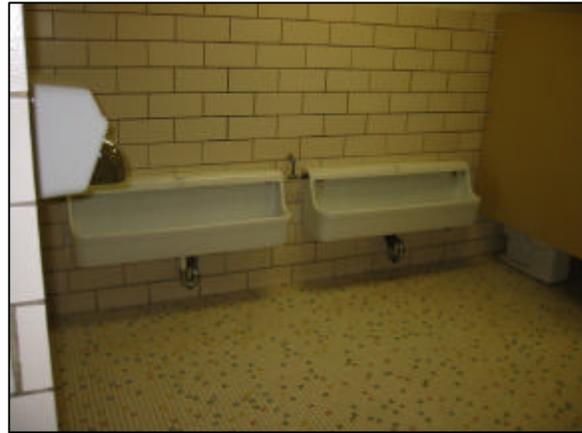
Non-compliant Bathroom

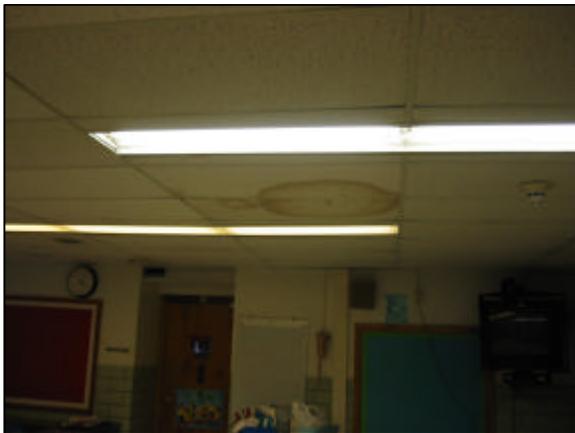
Poor Lights and Ceiling

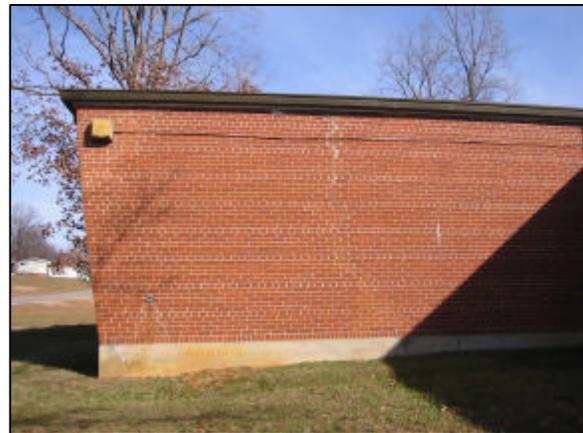
Foundation Settlement

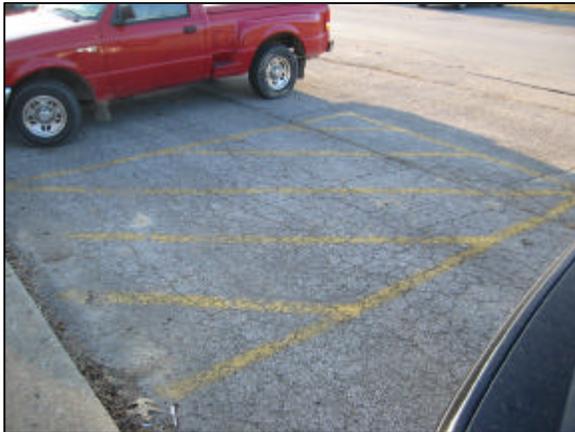
Paving in Poor Condition

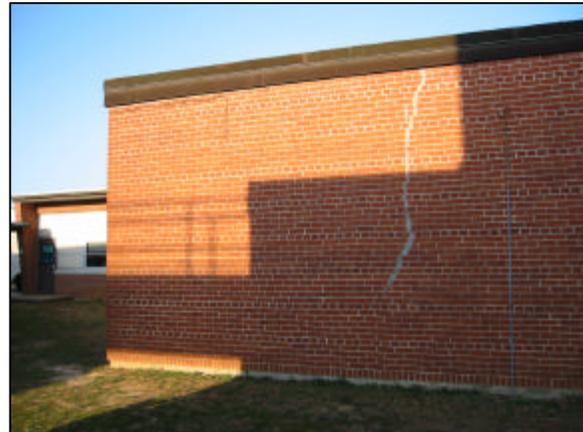
Cracked Masonry

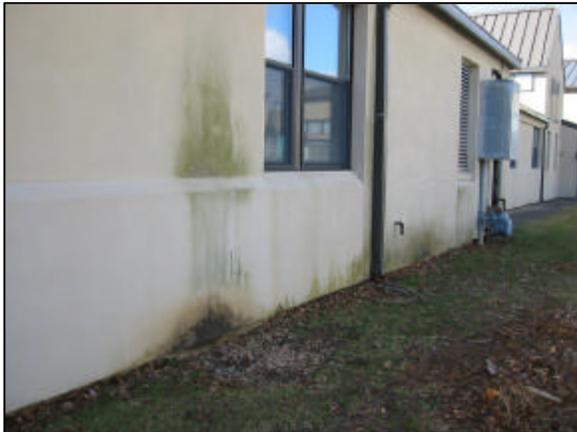
Damaged Wall Material

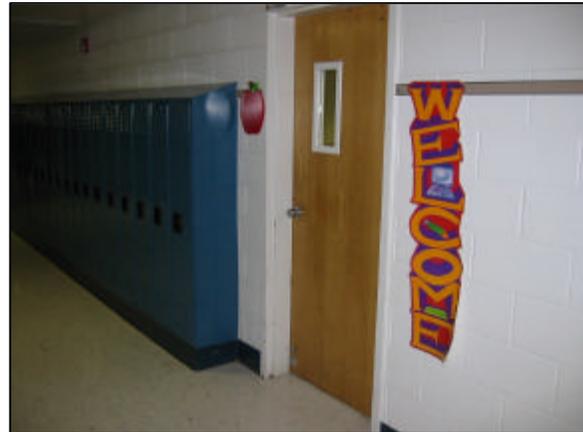
Non-ADA Door Hardware

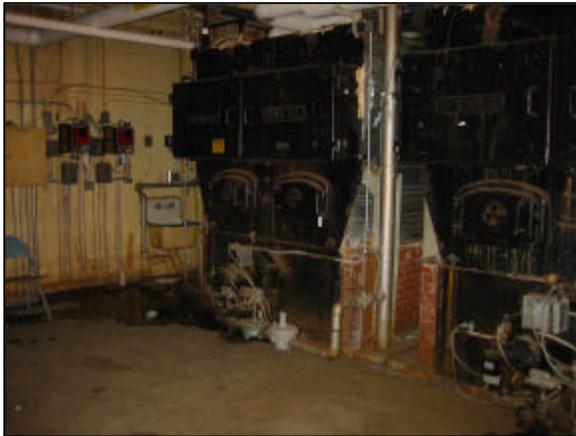
Old Spencer Boilers

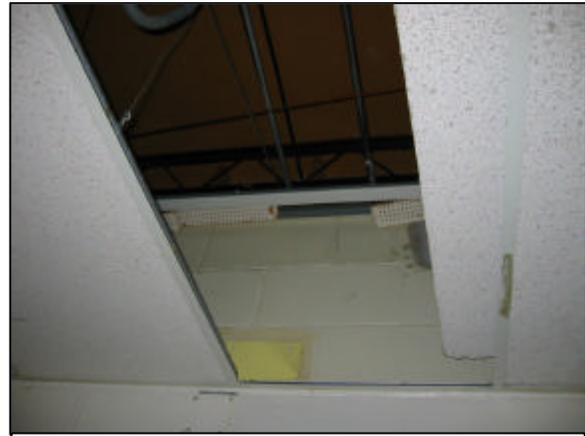
Unsealed Corridor Wall at Roof Deck

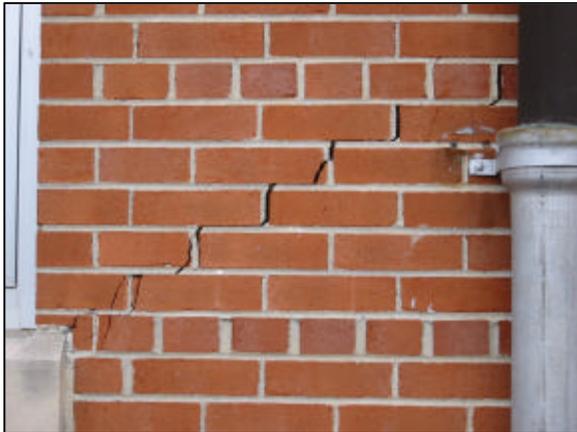
Cracked Masonry

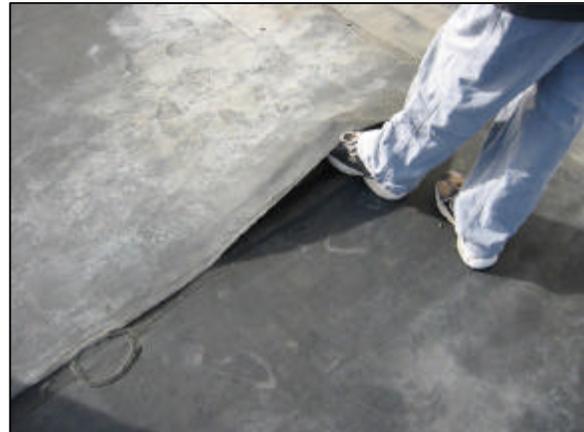
Damaged Roof

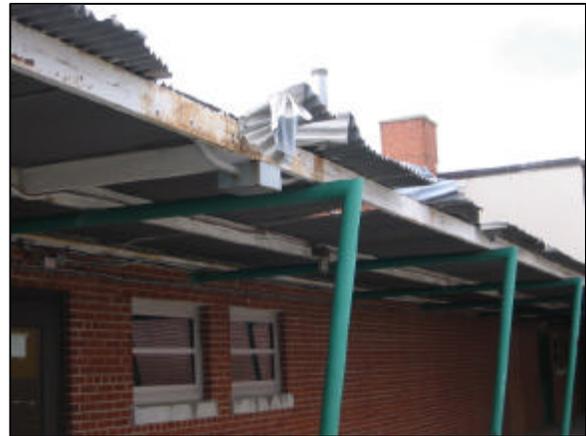
Photo 2: Damaged Covered Walk Structures

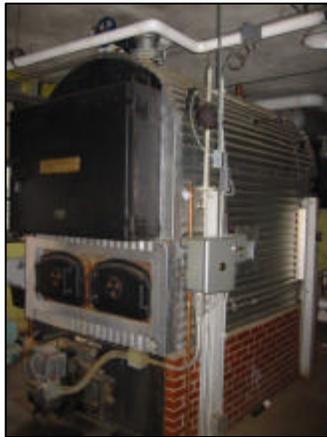
Photo 3: Replace Old Boiler

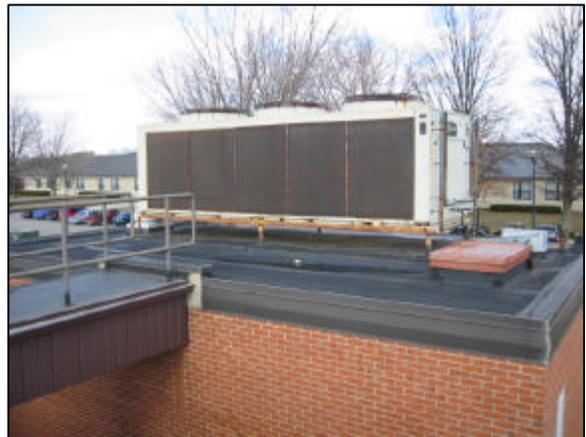
Photo 4: Rusting Condensing Unit

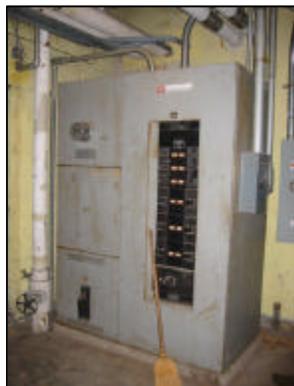
Photo 5: Main Electrical Panel Poor Condition

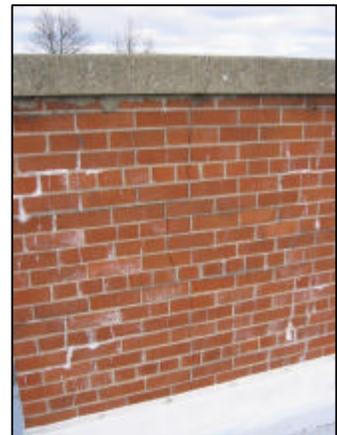
Photo 6: Damaged Masonry

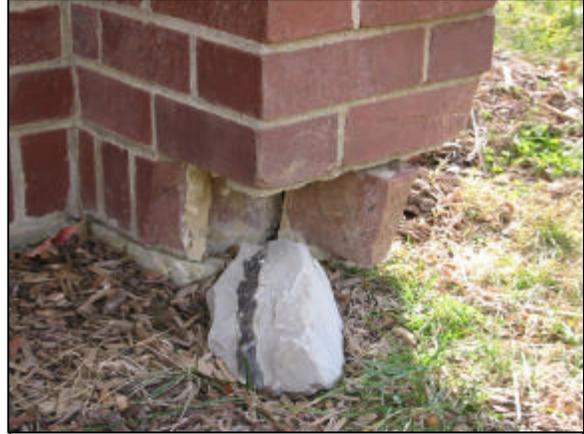
Photo 2: Damaged Masonry

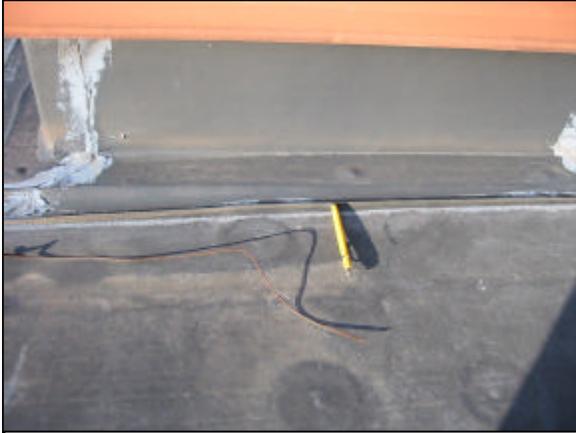
Photo 3: EPDM Flashing Problem

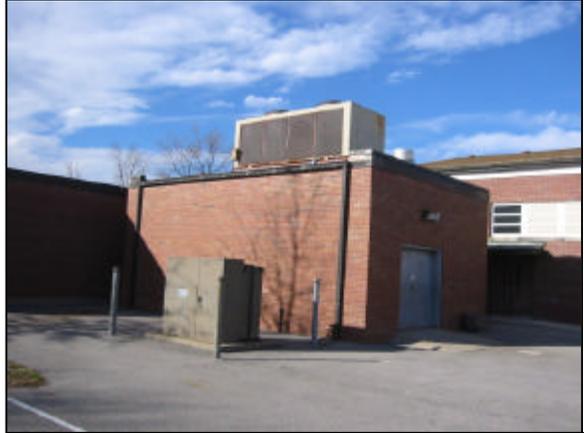
Photo 4: Rusted Condensing Unit on Chiller Roof

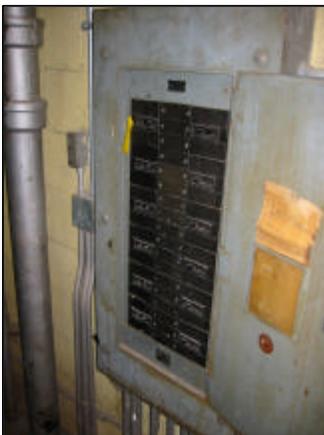
Photo 5: Old Electrical Panel

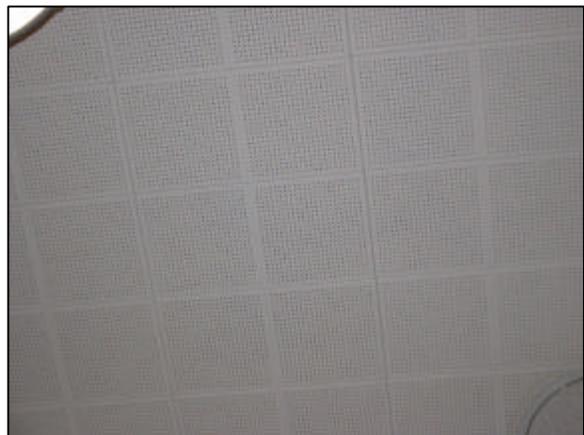
Photo 6: Asbestos Ceiling Tile Mastic

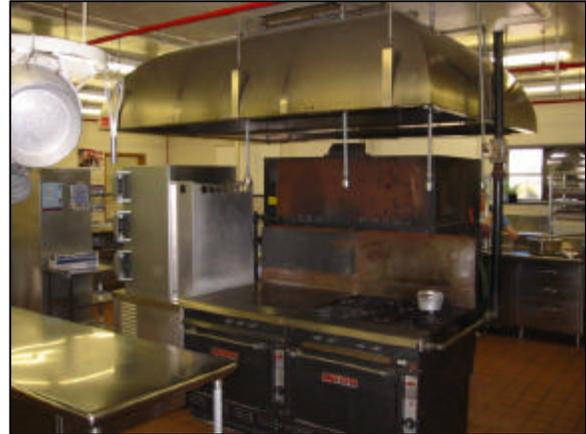
Photo 2: Non-compliant Kitchen Hood

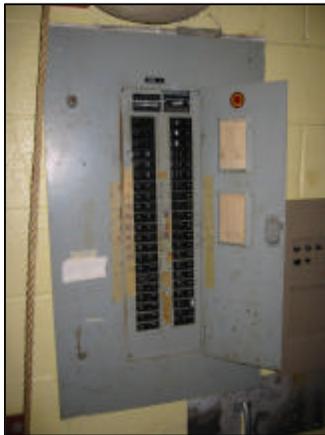
Photo 3: Replace Old Distribution Panels

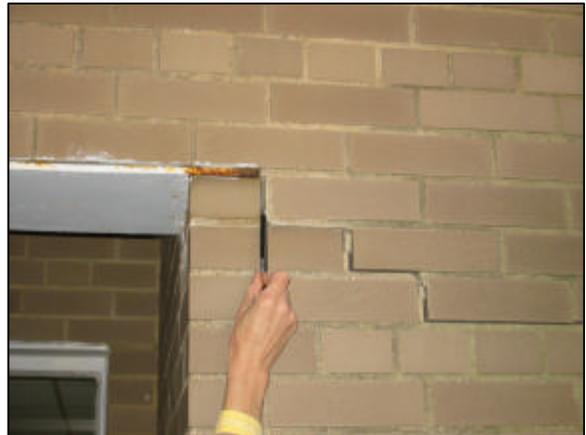
Photo 4: Repair Damaged Masonry

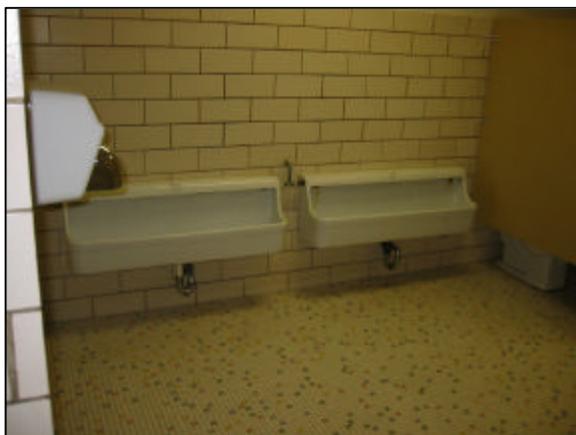
Photo 5: Non-compliant Urinals

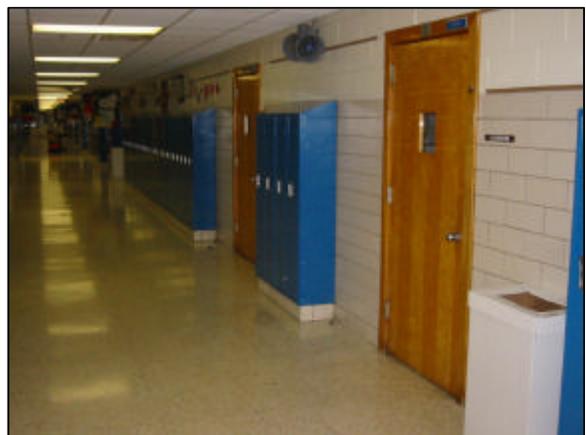
Photo 6: Non-compliant Door Hardware

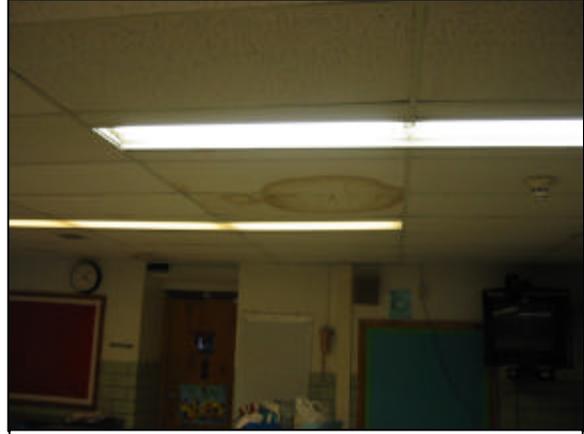
Photo 2: Poor Lights and Ceiling

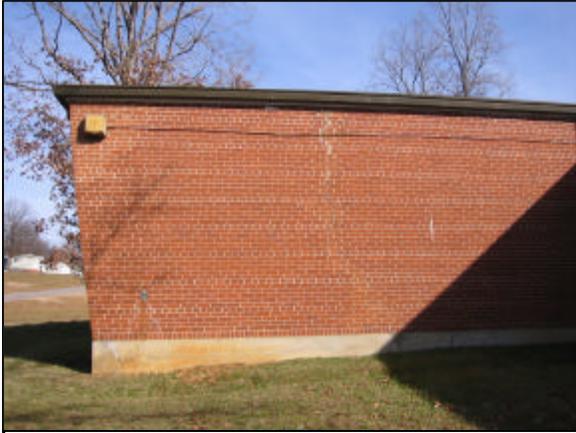
Photo 3: Foundation Settlement

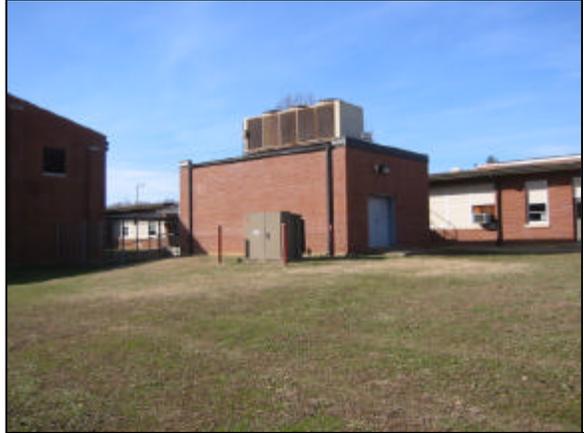
Photo 4: Condensing Unit in Poor Condition

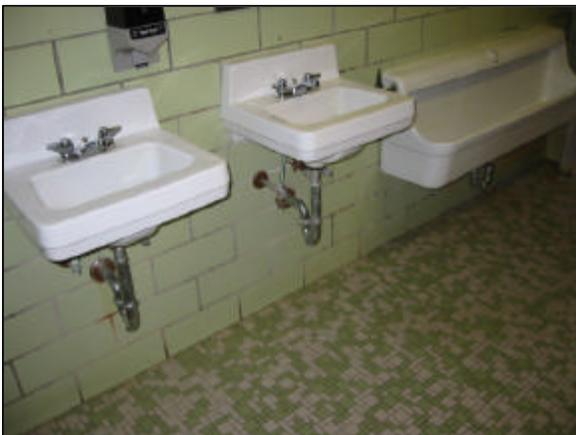
Photo 5: Non-compliant Toilet Room

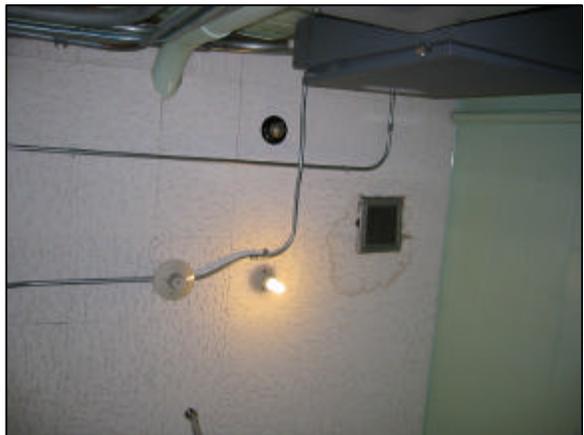
Photo 6: ACM Mastic Behind Ceiling Tile

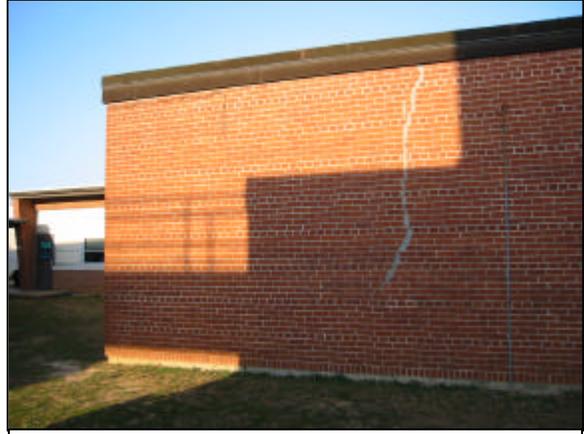
Photo 2: Cracked Masonry

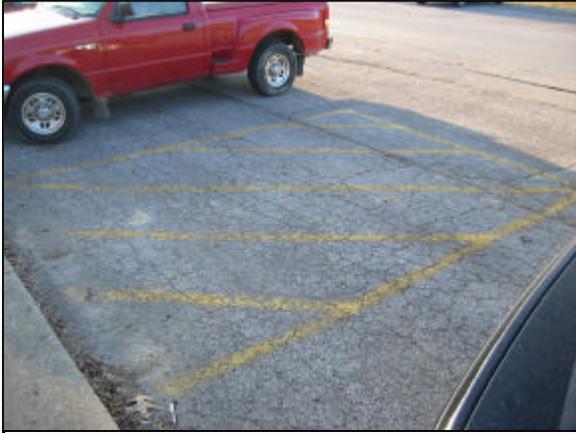
Photo 3: Paving in Poor Condition

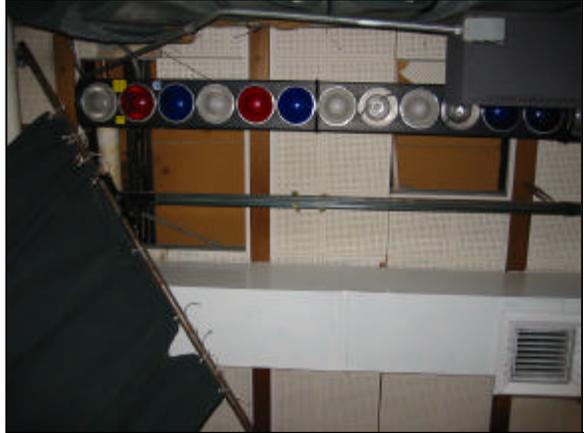
Photo 4: No Fire Sprinkler Above Stage

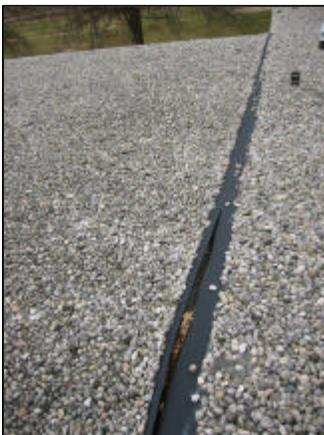
Photo 5: Damaged Built-up Roofing

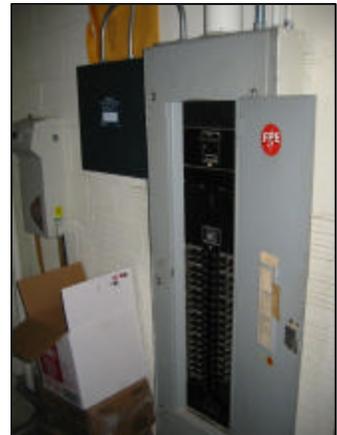
Photo 6: Upgrade Electrical Panel

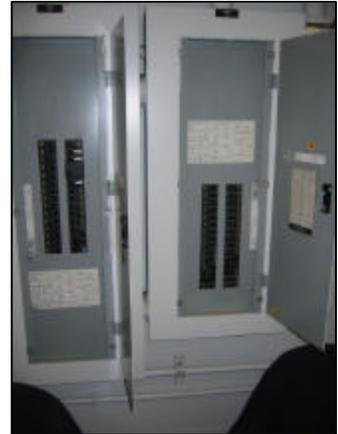
Photo 2: Provide Additional Distribution Panels

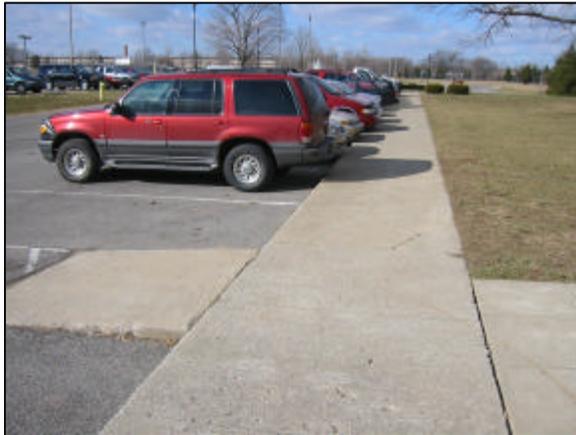
Photo 3: Sidewalks in Poor Condition

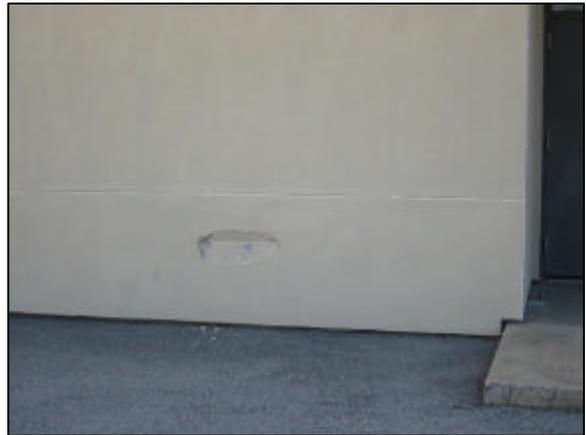
Photo 4: Damaged Exterior Wall

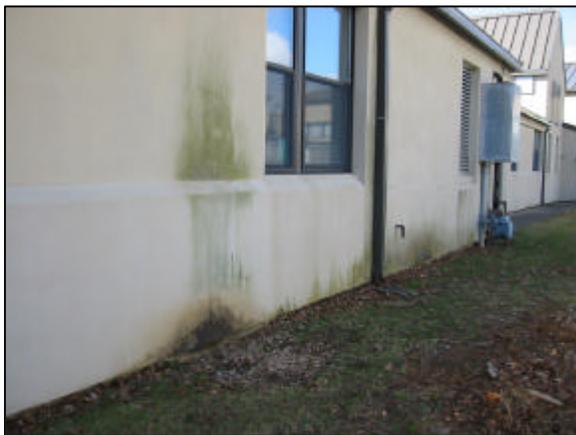
Photo 5: Damaged Wall Material

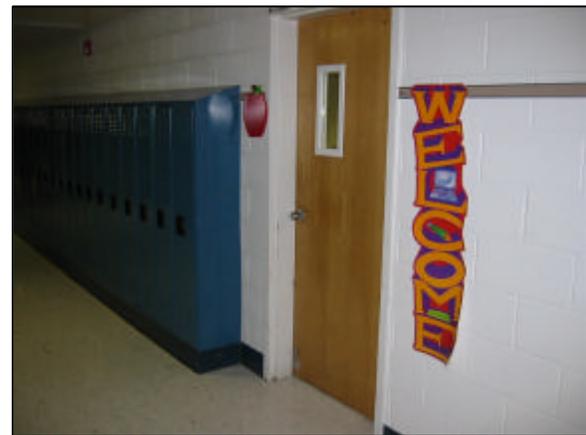
Photo 6: Non-ADA Door Hardware

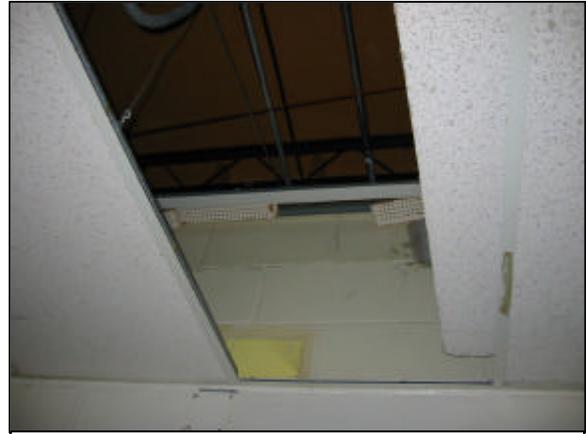
Photo 2: Unsealed Corridor Wall at Roof Deck

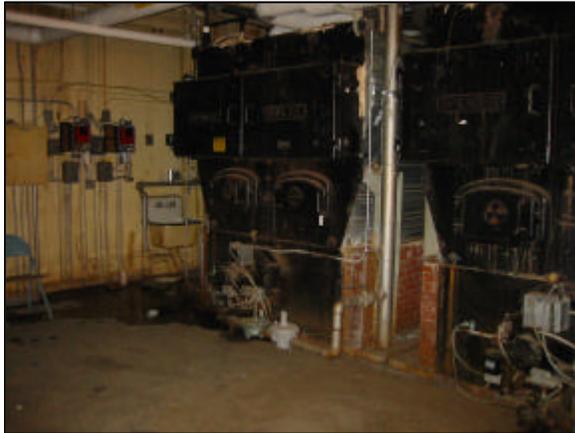
Photo 3: Old Spencer Boilers

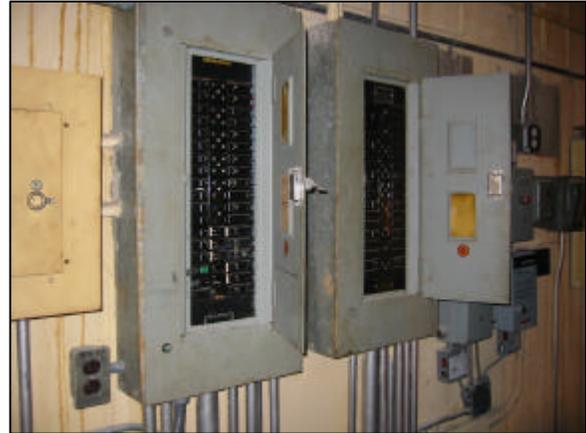
Photo 4: Upgrade Electrical Panels

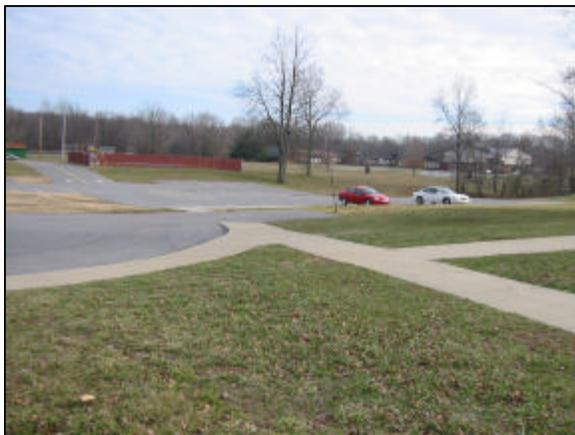
Photo 5: Non-accessible Route to Parking

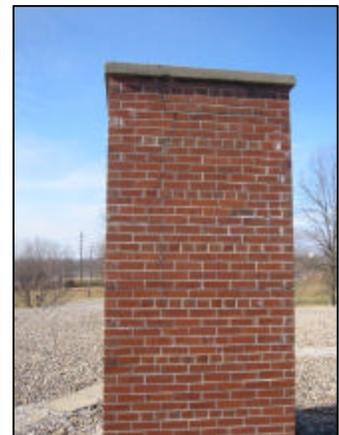
Photo 6: Damaged Masonry

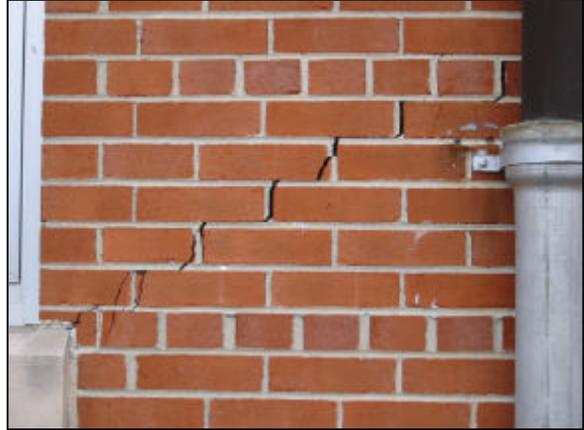
Photo 2: Cracked Masonry

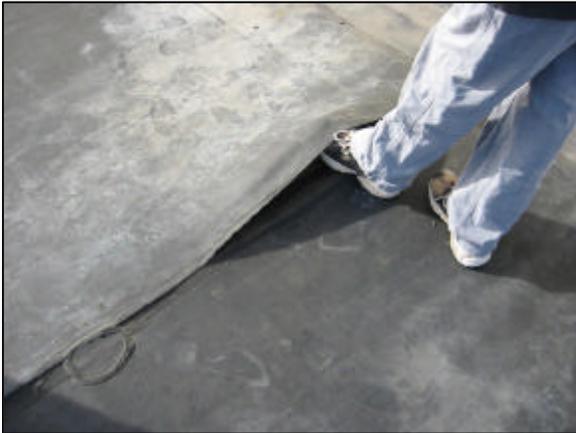
Photo 3: Damaged Roof

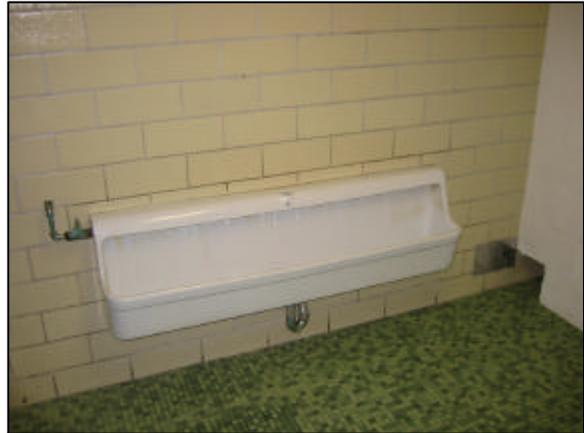
Photo 4: Non-compliant Toilet Room

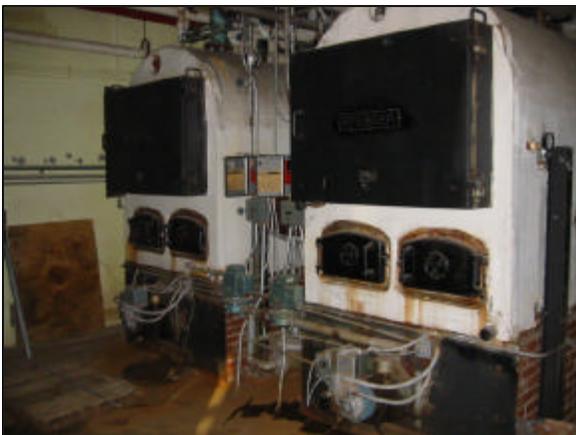
Photo 5: Old Boilers

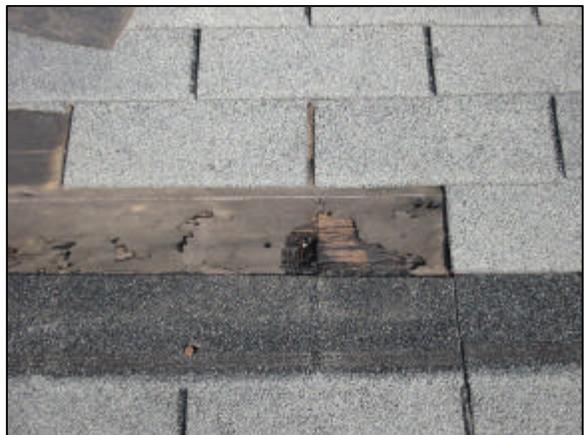
Photo 6: Damaged Composition Shingle
