DDESS Facility Transfer Study Facility Condition Report (Final)

December 10, 2003

PSC Project # 03811102

FORT BRAGG SCHOOLS
FORT BRAGG, NORTH CAROLINA
PROPERTY CONDITION REPORT

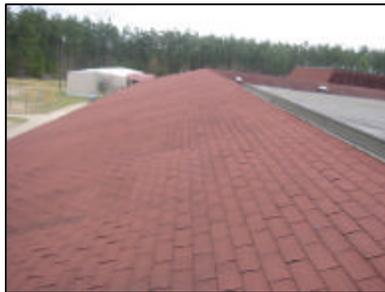
Damaged Roofing

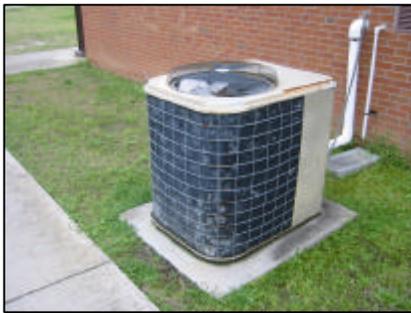
Condenser in Poor Condition

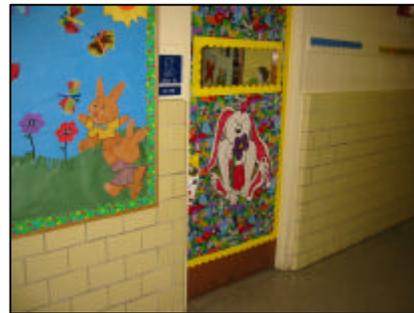
ADA Non-compliant Door

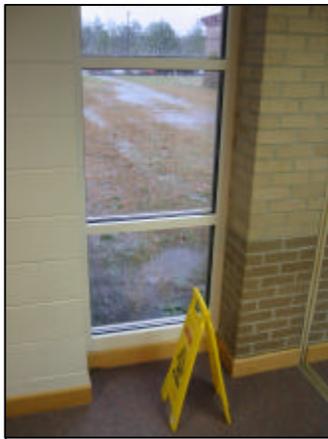
Drainage Problems

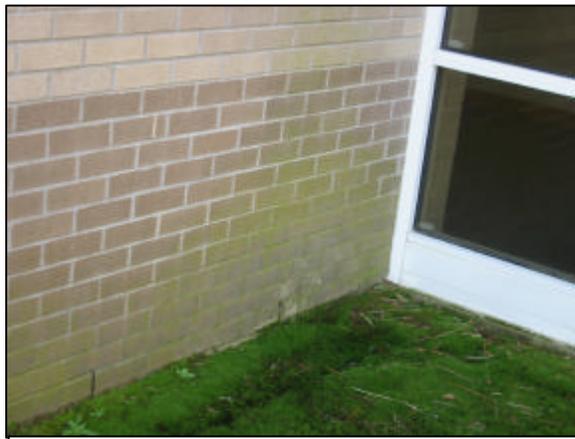
Water Retention Problem

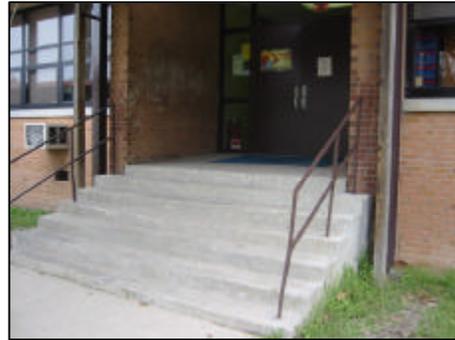
ADA Non-compliant Exit/Entrance

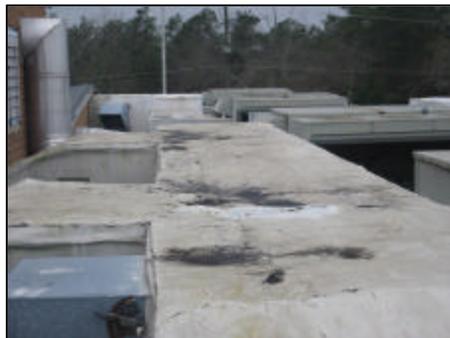
Deteriorated Exterior Ductwork

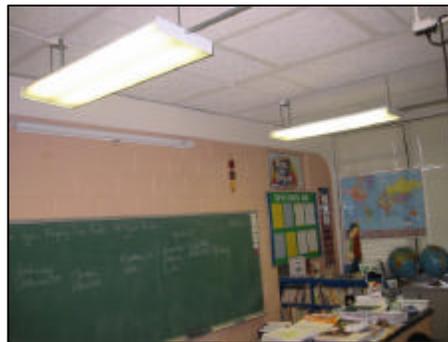
Poor Lighting

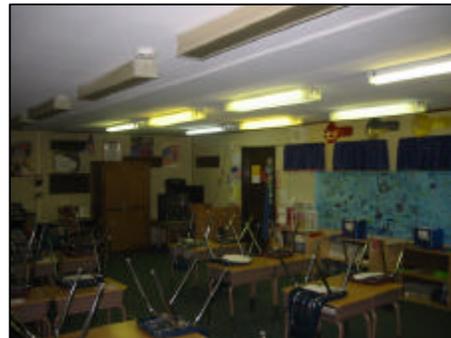
Poor Classroom Lighting

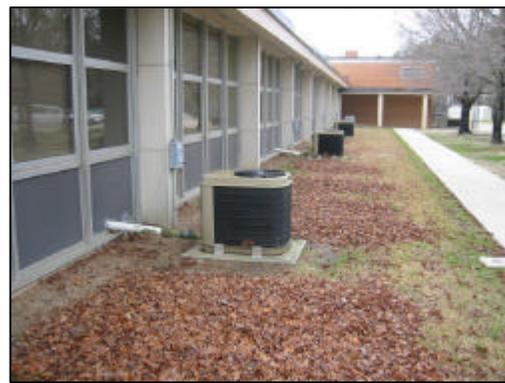
Old Pad Mounted Condensers

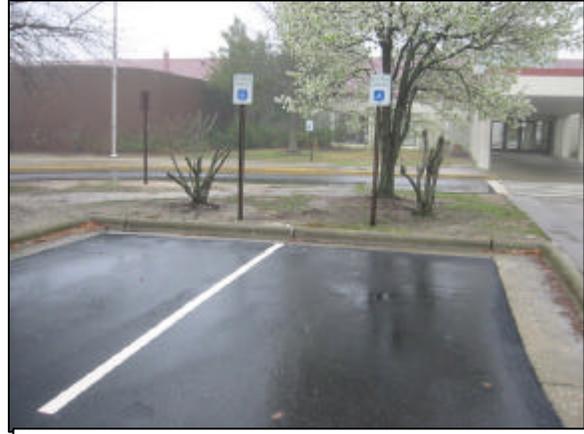
Photo 2: ADA Non-compliant Parking

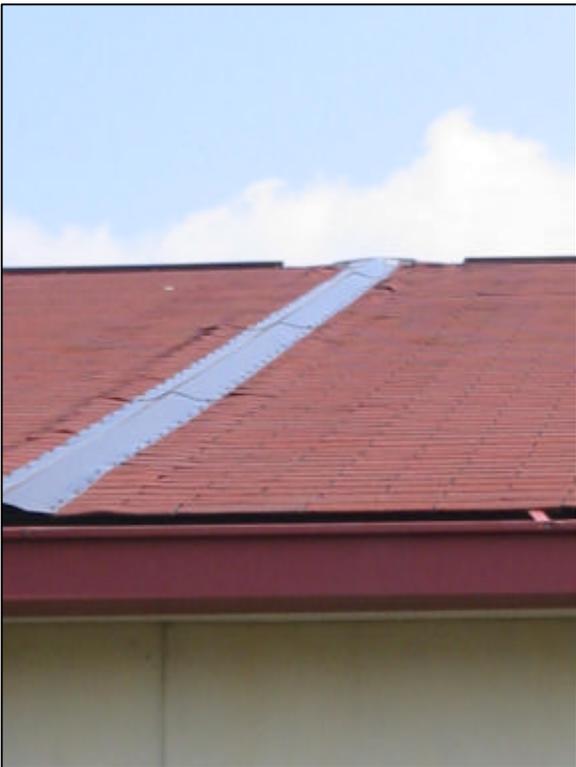
Photo 3: Roof EJ Problem

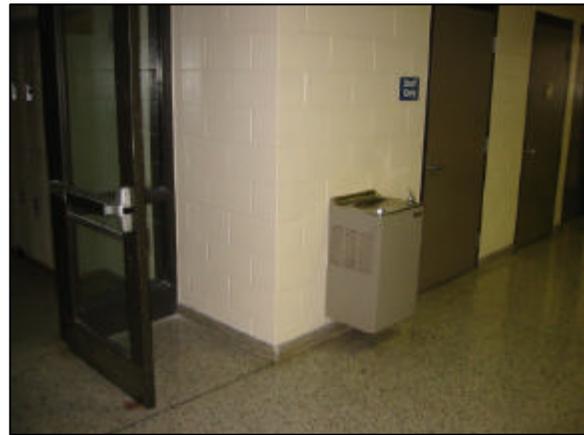
Photo 4: ADA Non-compliant Drinking Fountain

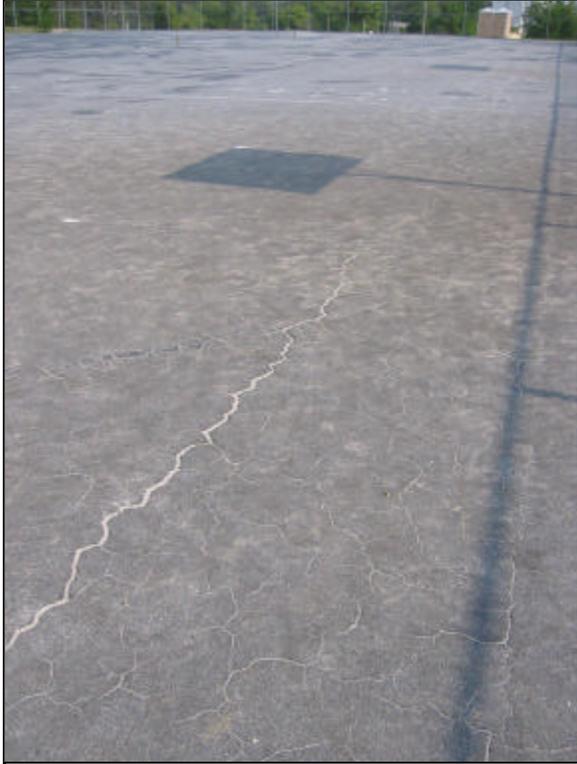
Photo 5: Tennis Court in Poor Condition

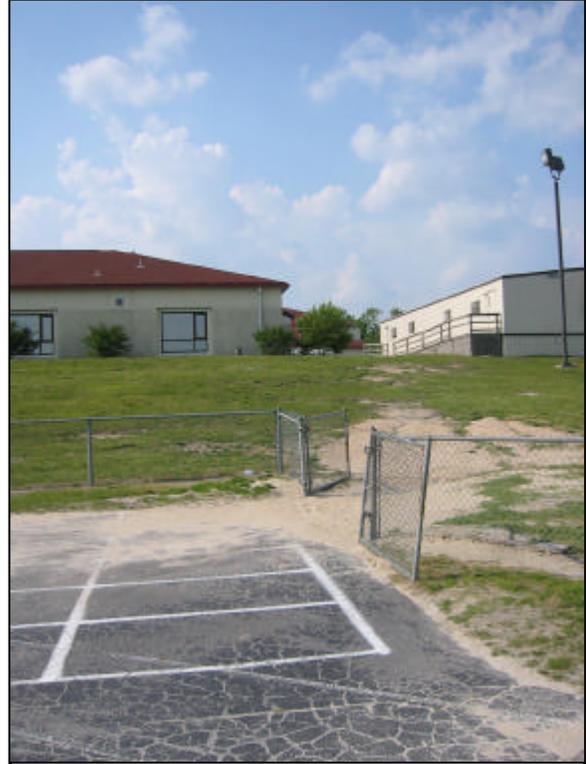
Photo 6: Track in Poor Condition

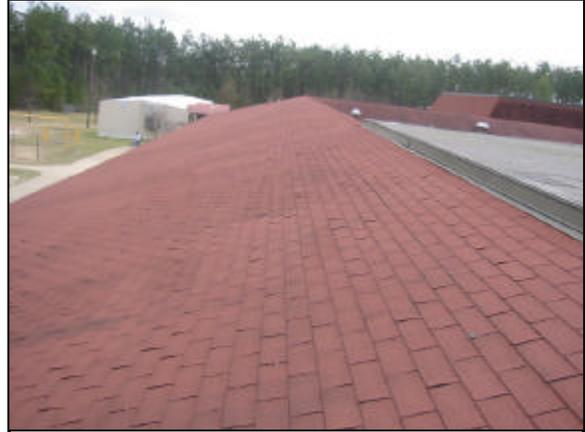
Photo 2: Damaged Roofing

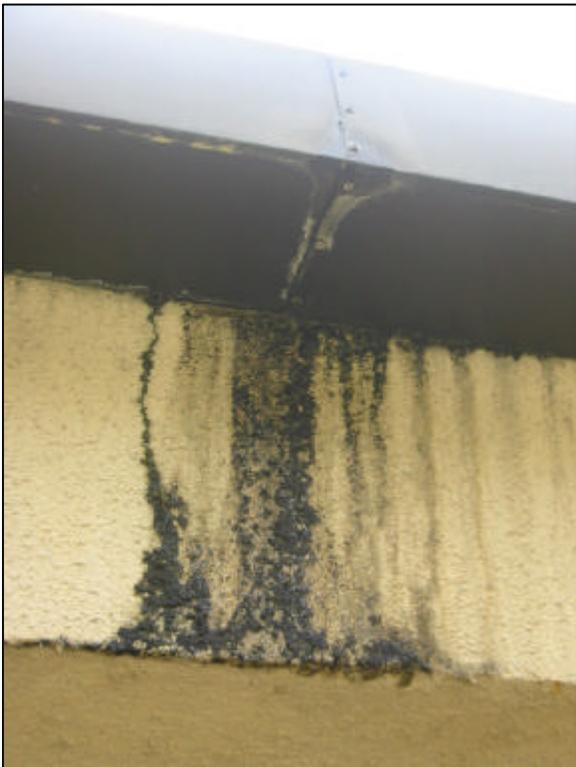
Photo 3: Damaged Soffit

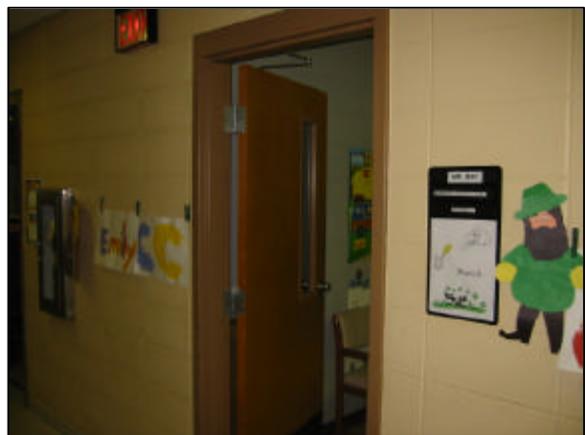
Photo 4: ADA Non-compliant Door

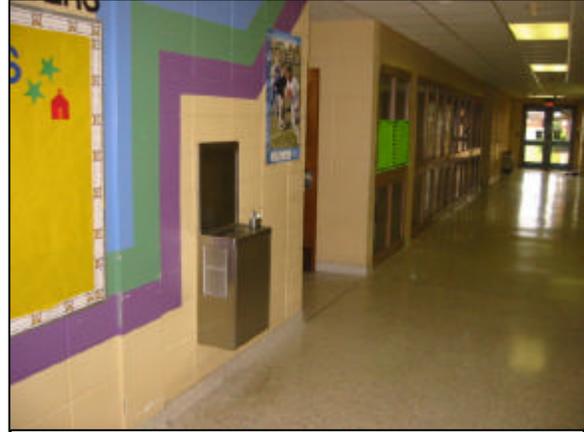
Photo 6: ADA Non-compliant Drinking Fountain

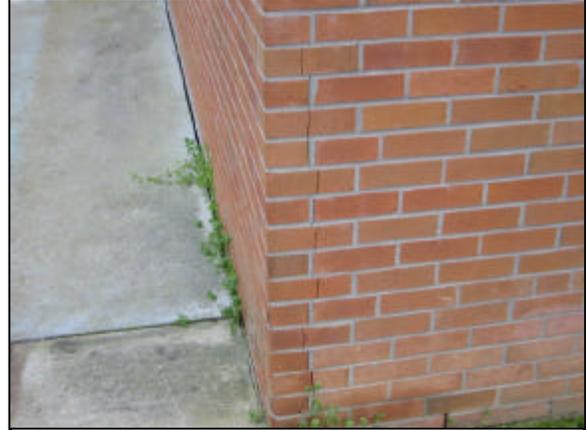
Photo 2: Damaged Masonry

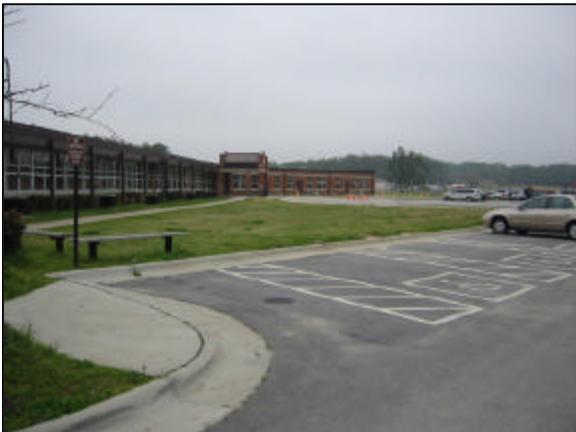
Photo 3: ADA Non-compliant Parking

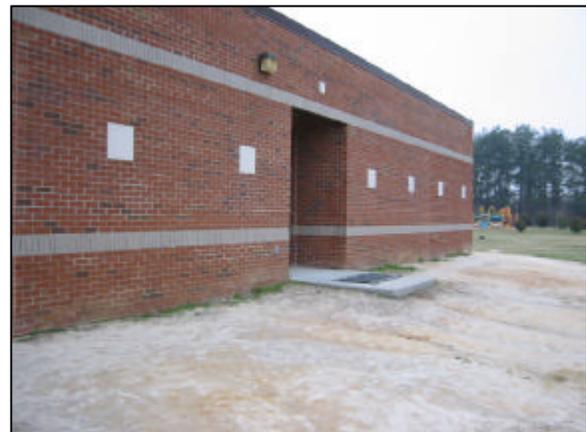
Photo 4: ADA Non-compliant Exit/Entrance

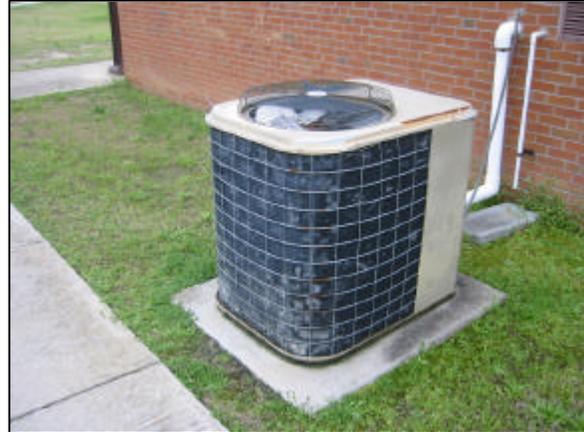
Photo 6: Condenser in Poor Condition

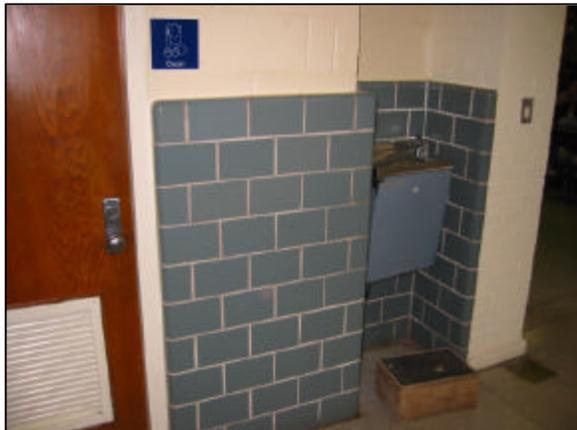
Photo 7: ADA Non-compliant Drinking Fountain

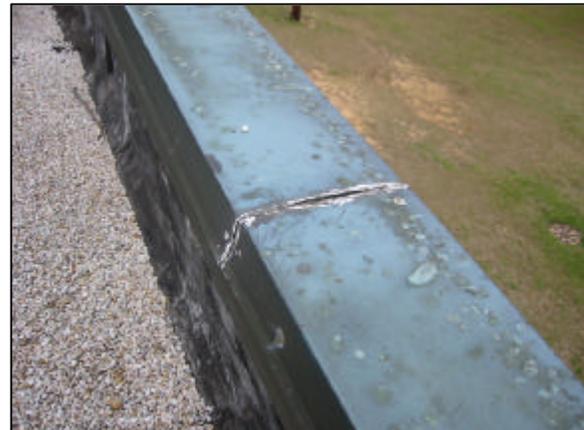
Photo 8: Damaged Coping

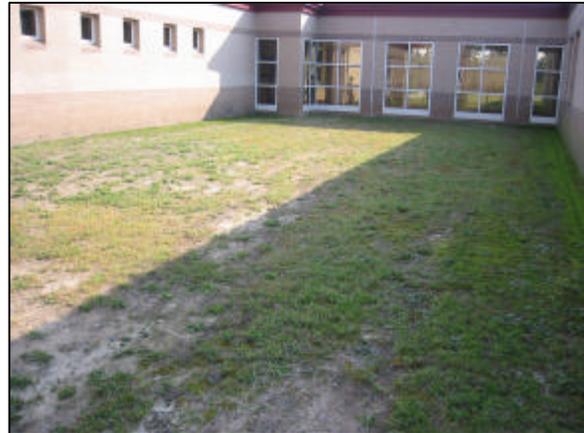
Photo 2: Topography/Drainage Problems

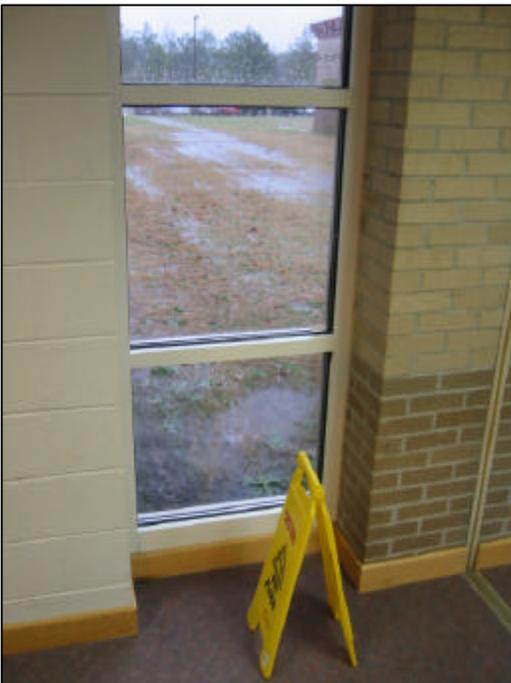
Photo 3: Drainage Problems

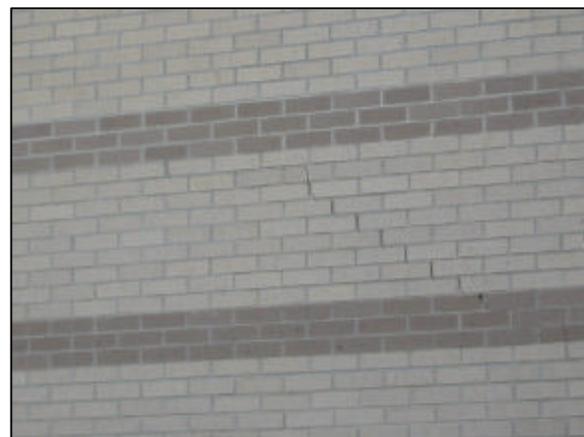
Photo 4: Damaged Masonry

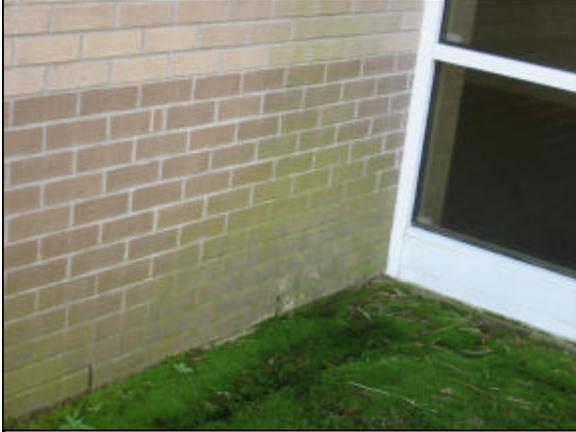
Photo 5: Water Retention Problem

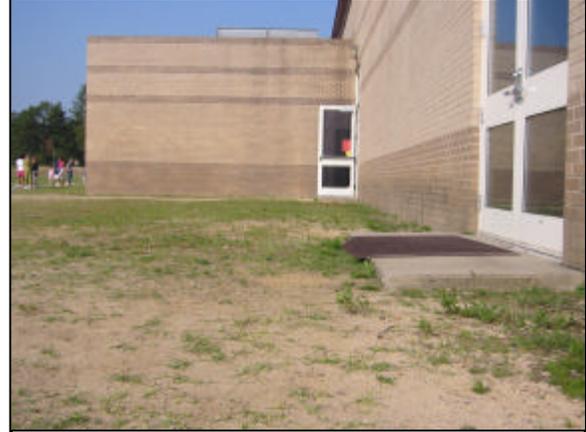
Photo 6: ADA Non-compliant Exit/Entrance

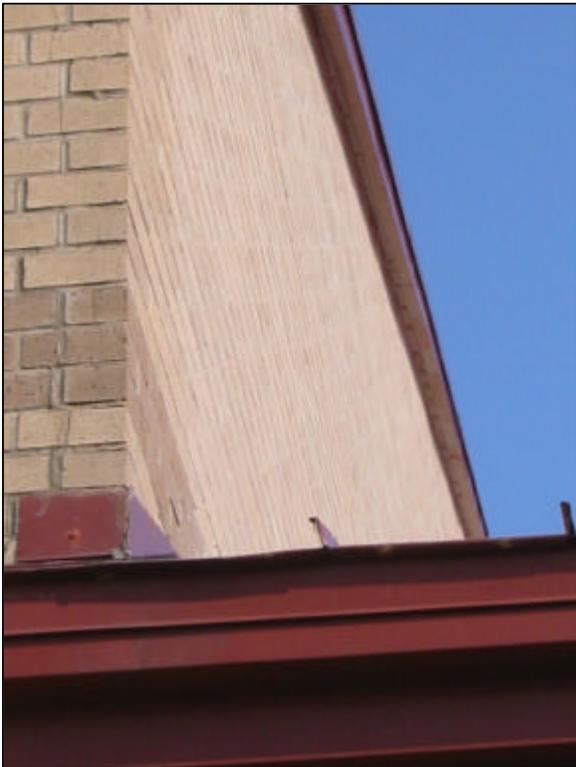
Photo 7: Brick Crack at Multipurpose Room

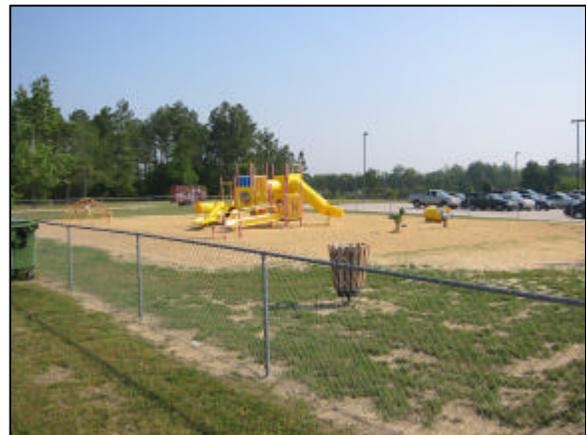
Photo 8: ADA Non-compliant Play Area

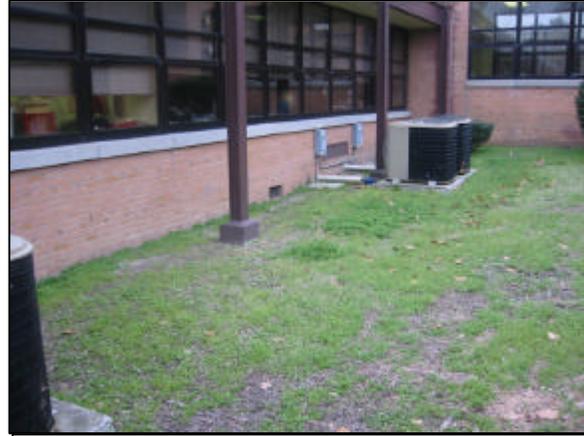
Photo 2: Drainage Problem

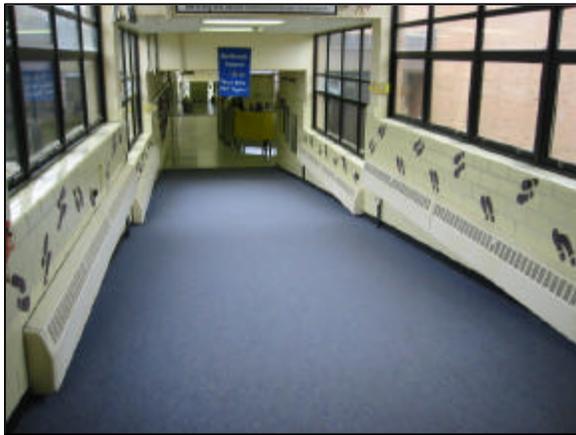
Photo 3: ADA Non-compliant Interior Sign

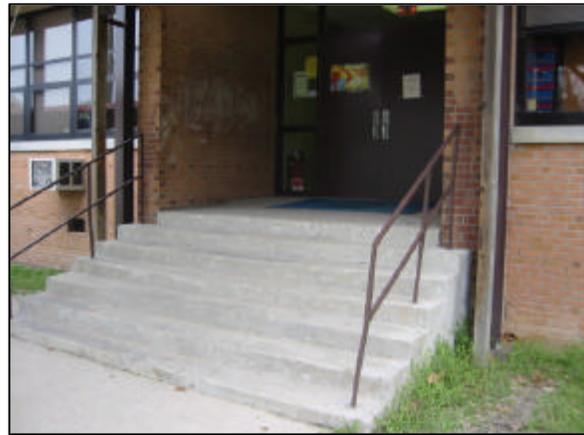
Photo 4: ADA Non-compliant Exit/Entrance

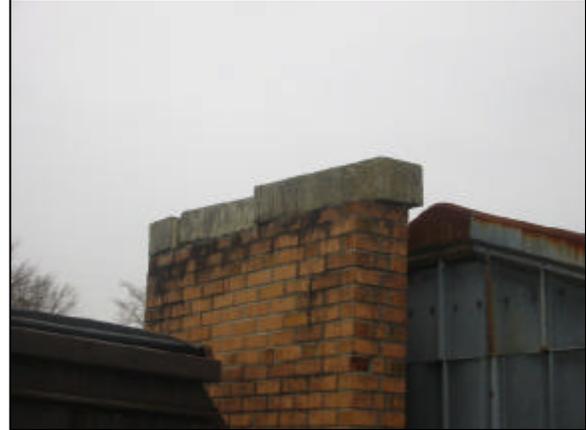
Photo 6: Damaged Coping

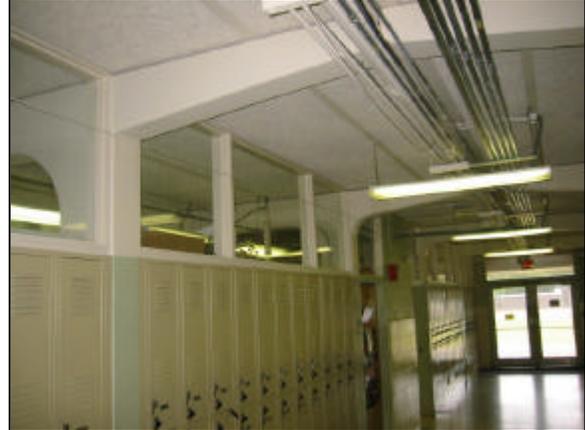
Photo 2: Non-rated Corridor Glass

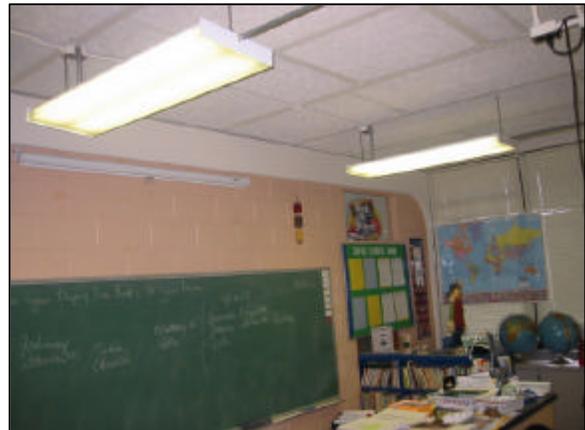
Photo 4: Poor Lighting

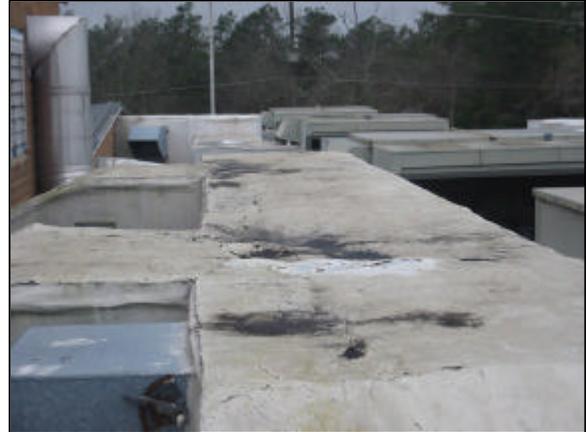
Photo 6: Deteriorated Exterior Ductwork

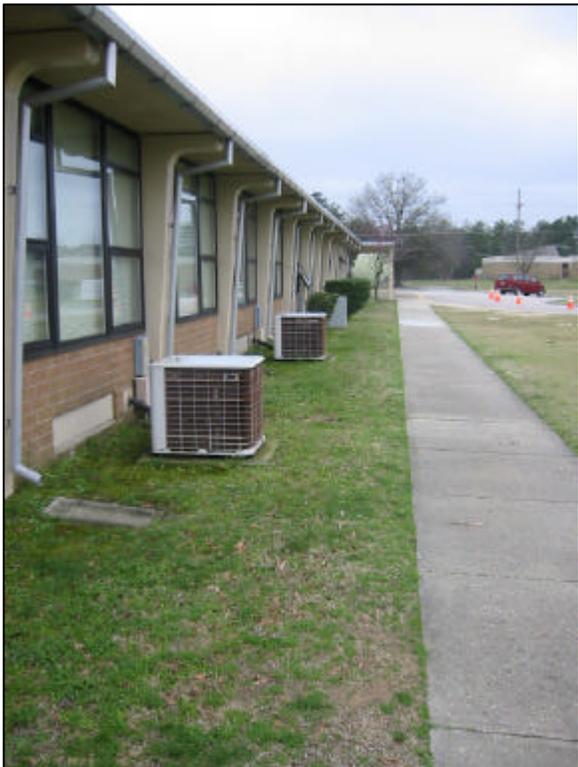
Photo 7: Old Condensing Units

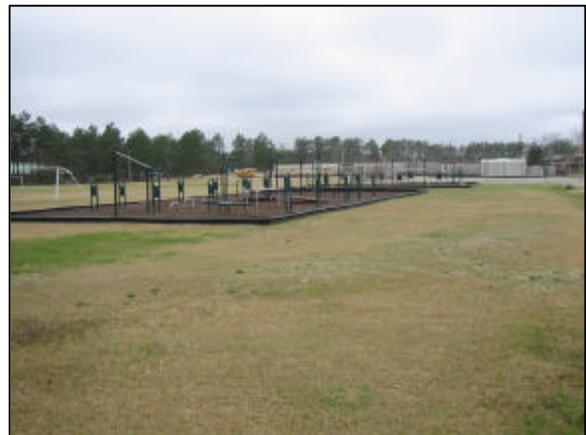
Photo 8: ADA Non-compliant Play Area

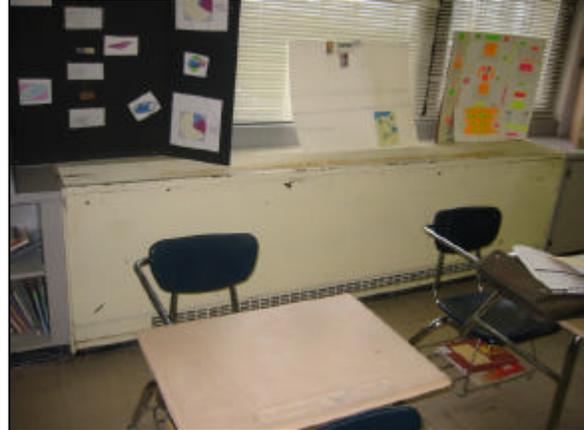
Photo 2: Old Fan Coil Units

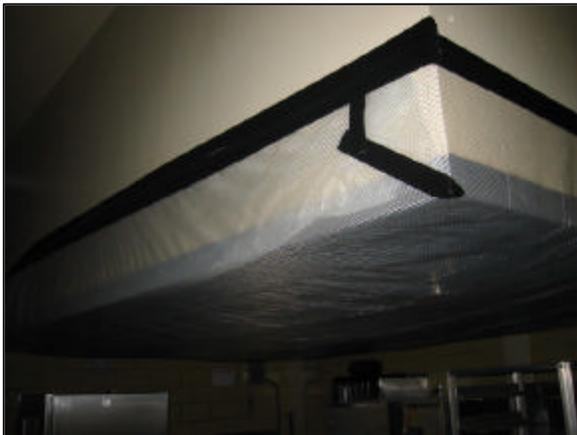
Photo 3: Non-Life Safety Compliant Kitchen Hood

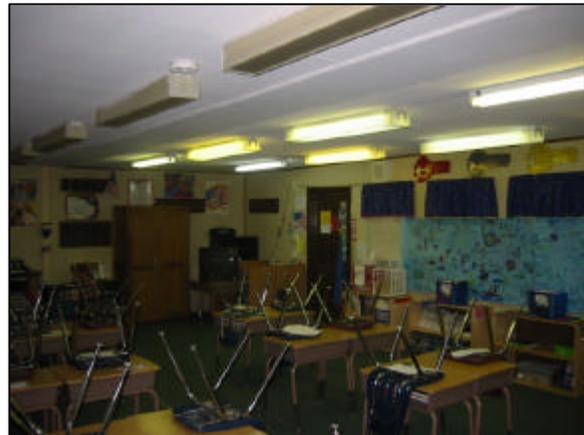
Photo 4: Poor Classroom Lighting

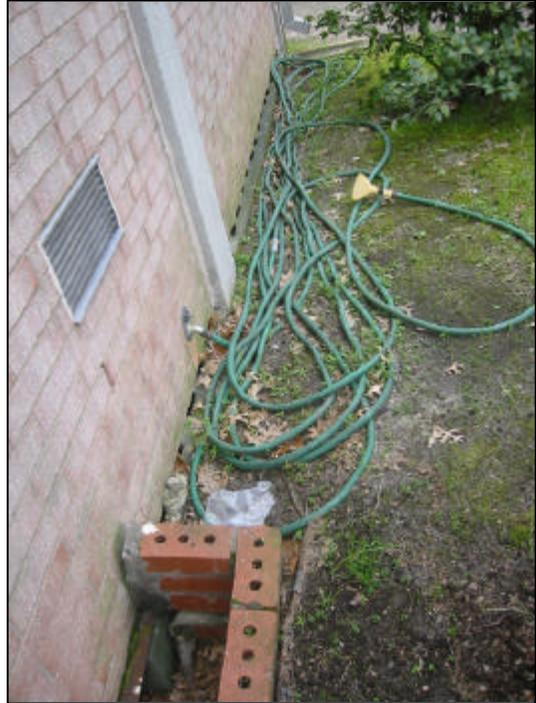
Photo 6: Drainage Problem at Foundation Wall

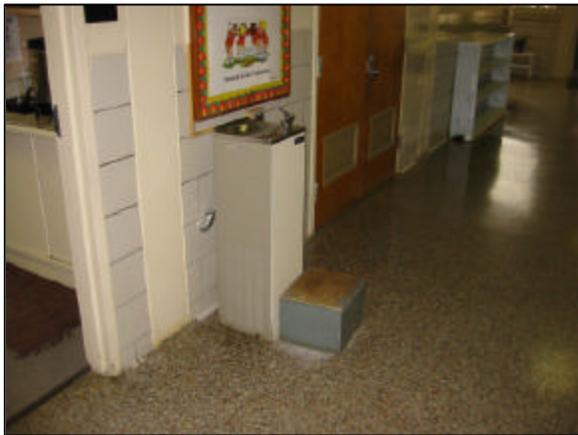
Photo 7: ADA Non-compliant Drinking Fountain

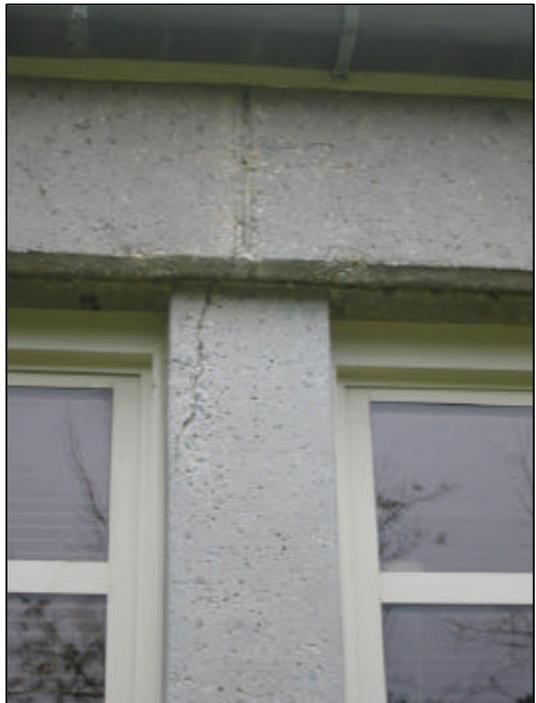
Photo 8: Cracked Concrete Column Cap

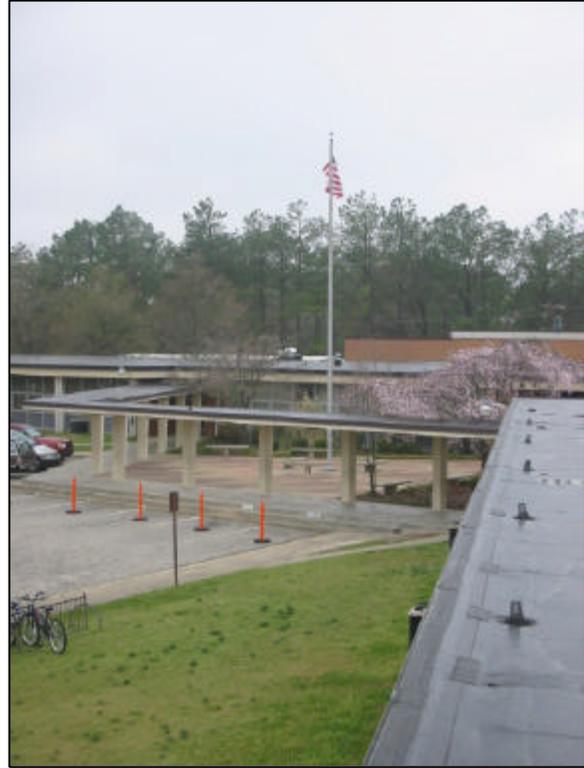
Photo 2: ADA Non-accessible Entry

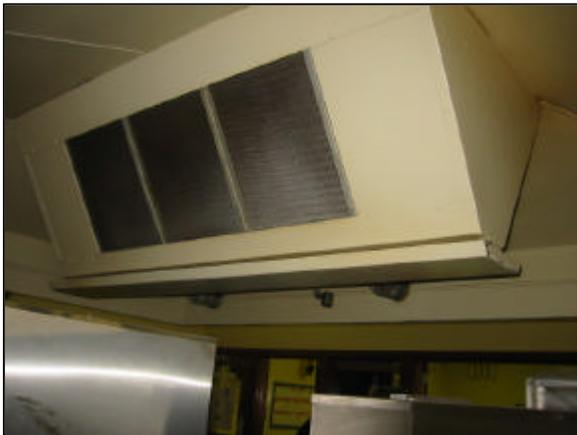
Photo 3: Exhaust Only Kitchen Hood

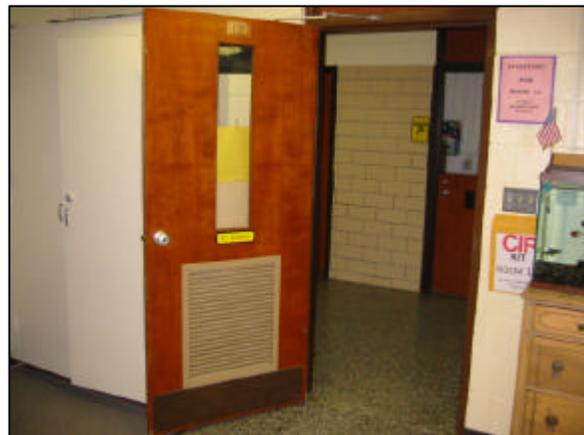
Photo 4: ADA Non-compliant Door, Signage and Life Safety Code Non-compliant Louvers

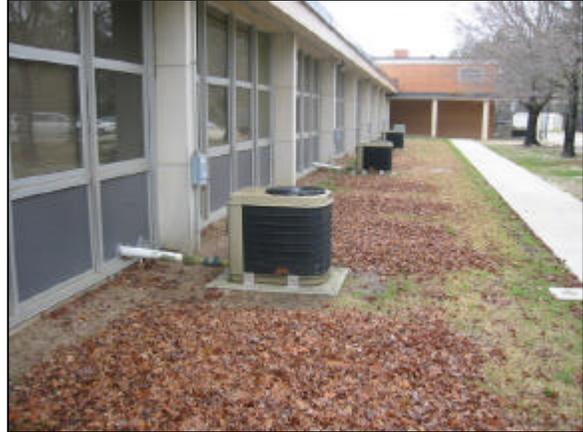
Photo 6: Old Pad Mounted Condensers

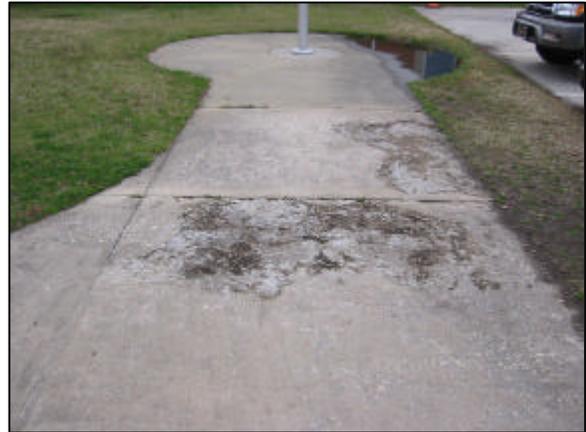
Photo 2: Damaged Walkway

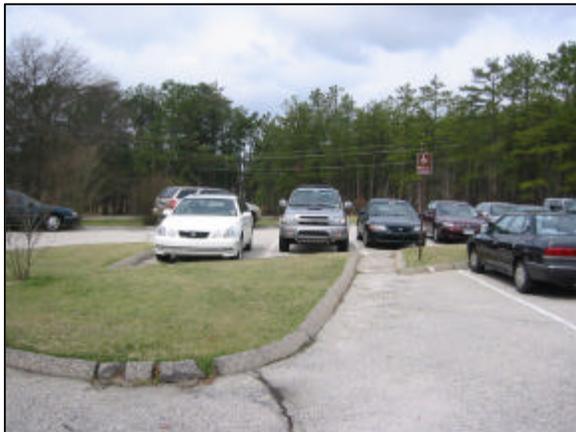
Photo 3: ADA Non-compliant Parking

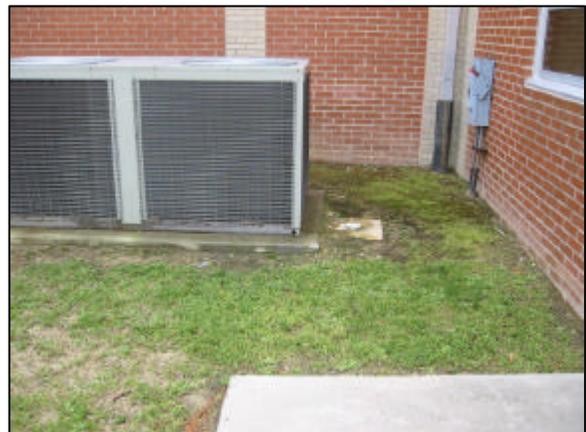
Photo 4: Moisture Problem at Condenser

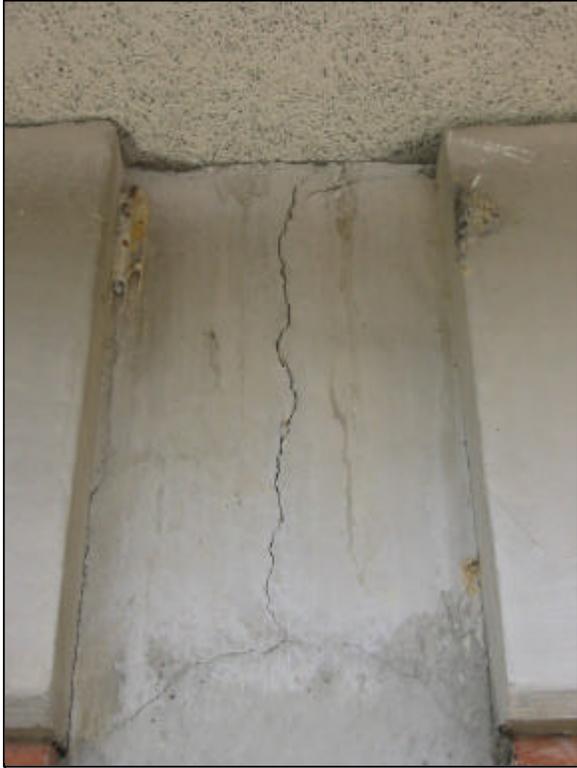
Photo 5: Concrete Column Damage

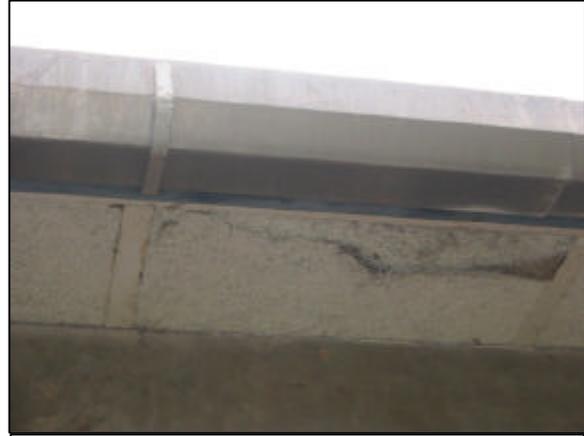
Photo 6: Damaged Soffit

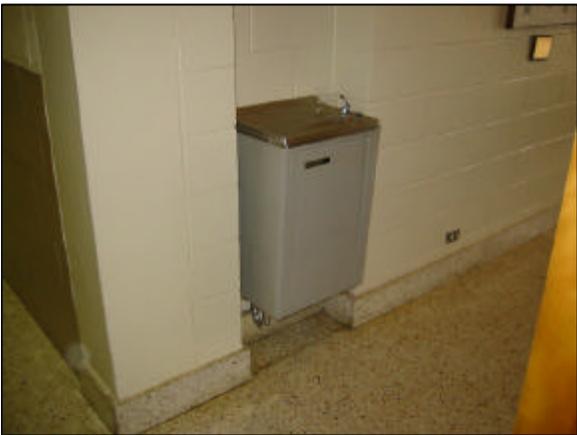
Photo 7: ADA Non-compliant Drinking Fountain

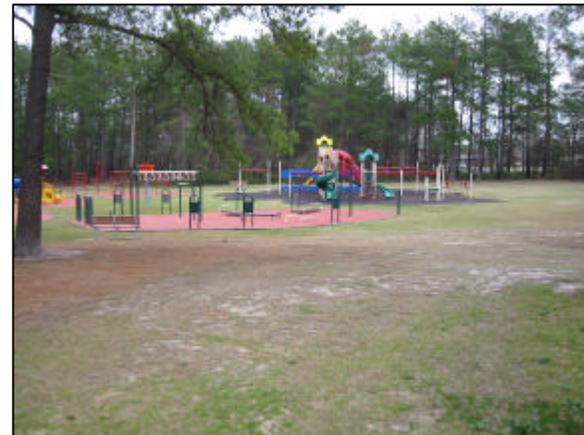
Photo 8: ADA Non-compliant Play Area
