# DDESS Facility Transfer Study Facility Condition Report (Final)

**Fort Stewart, Georgia**

December 10, 2003

FORT STEWART SCHOOLS  
FORT STEWART, GEORGIA  
PROPERTY CONDITION REPORT

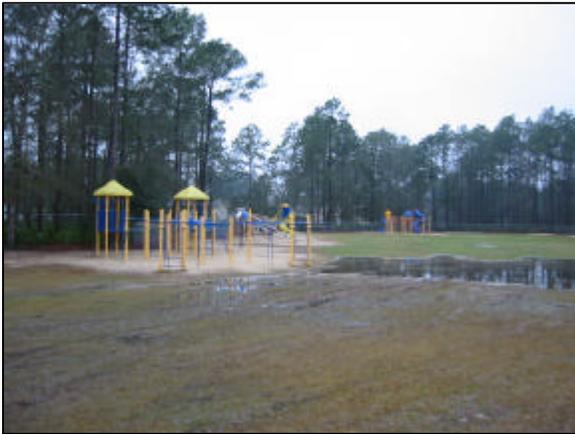
**Site Drainage Problems**

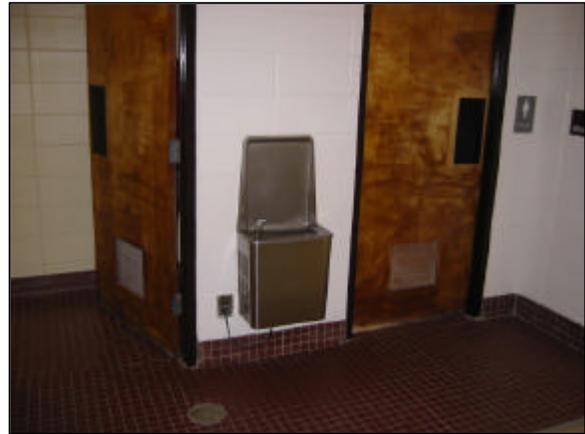
**ADA Non-compliant Drinking Fountain and Louvered Doors**

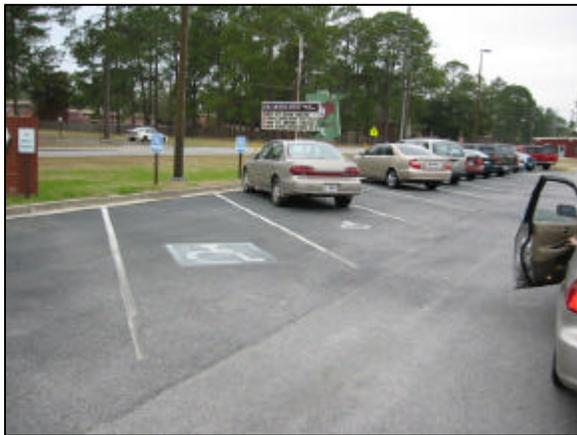
**ADA Non-compliant Parking**

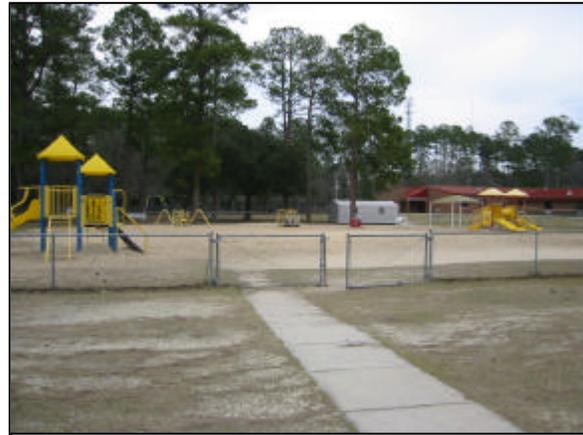
**ADA Non-compliant Play Area**

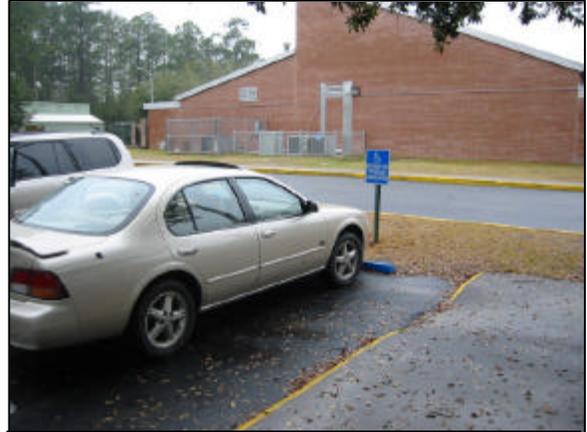
**Photo 2: ADA Non-compliant Parking**

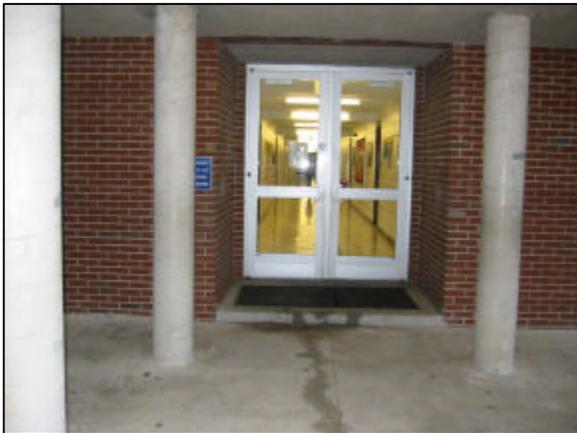
**Photo 3: ADA Non-compliant Exit/Entrance**

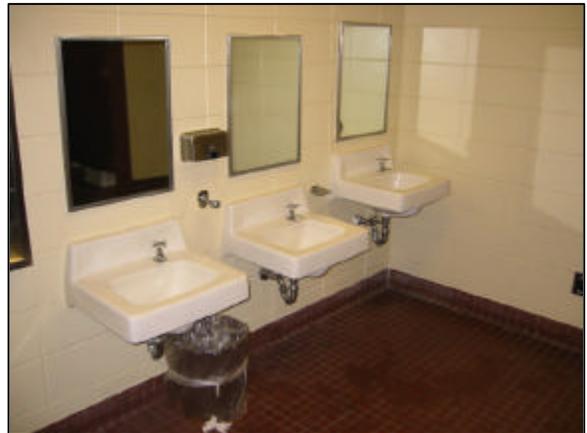
**Photo 4: ADA Non-compliant Toilet**

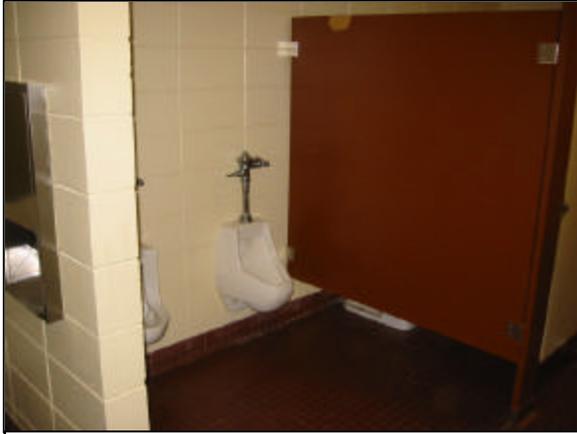
**Photo 5: ADA Non-compliant Toilet**

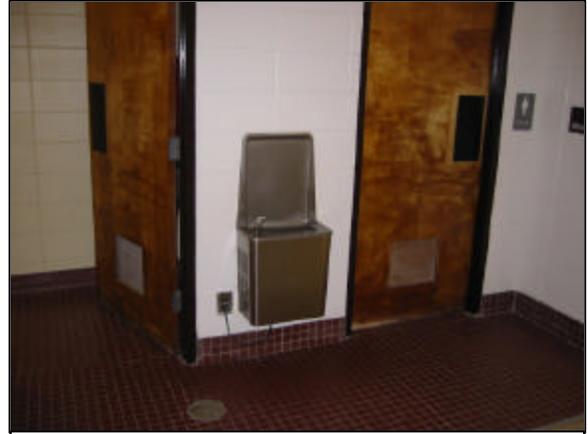
**Photo 6: ADA Non-compliant Drinking Fountain and Louvered Doors**

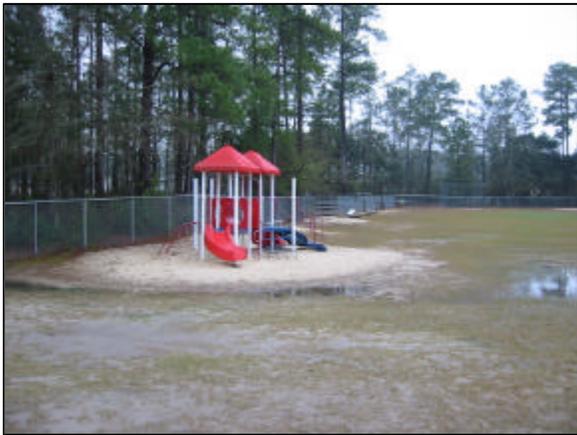
**Photo 7: ADA Non-compliant Playground**

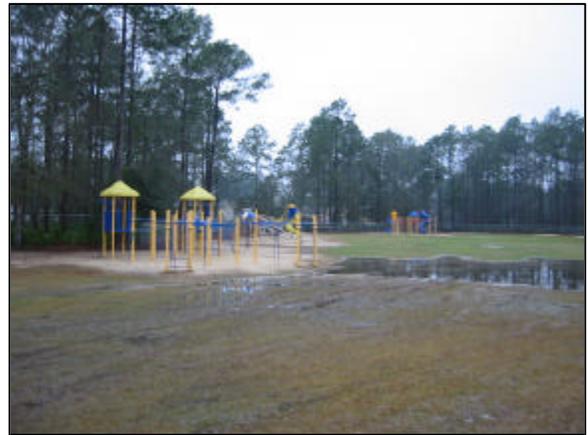
**Photo 8: Site Drainage Problems**

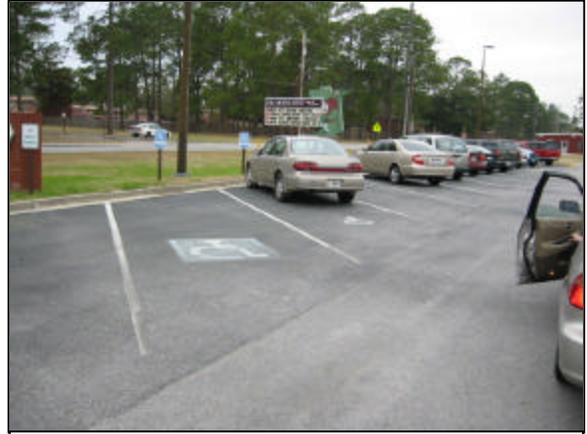
**Photo 2: ADA Non-compliant Parking**

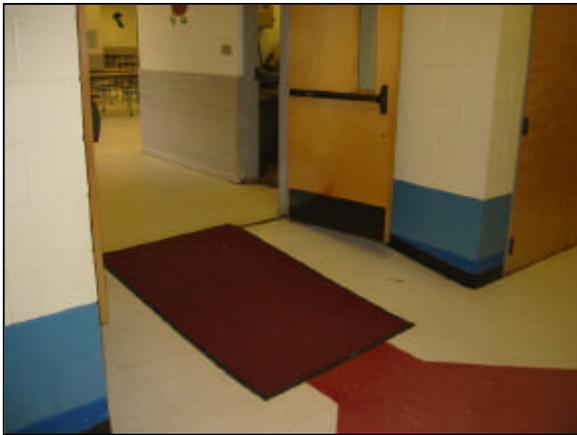
**Photo 3: ADA Non-compliant Interior Ramp**

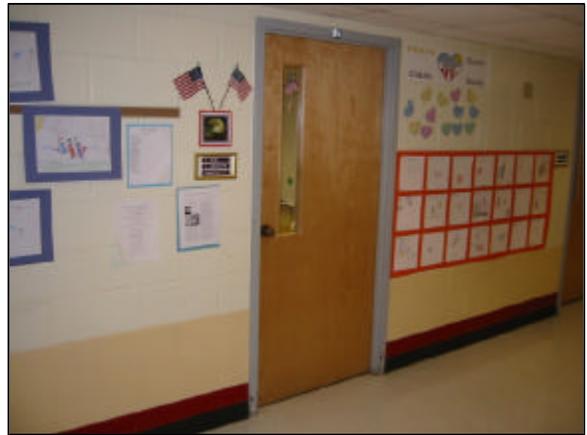
**Photo 4: ADA/Life Safety Non-compliant Door and Signage**

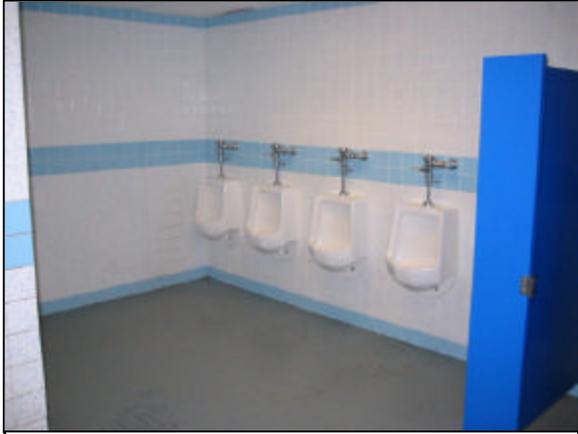
**Photo 5: ADA Non-compliant Toilet**

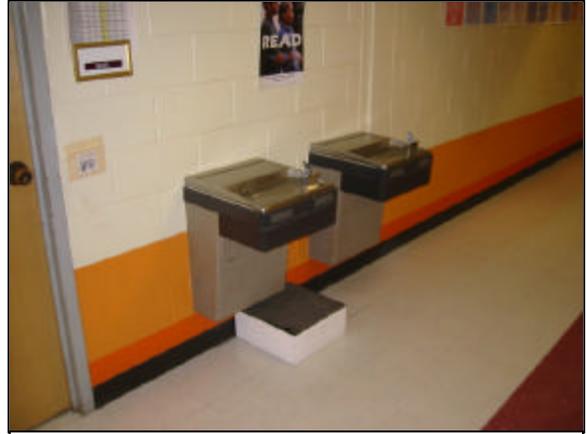
**Photo 6: ADA Non-compliant Drinking Fountains**

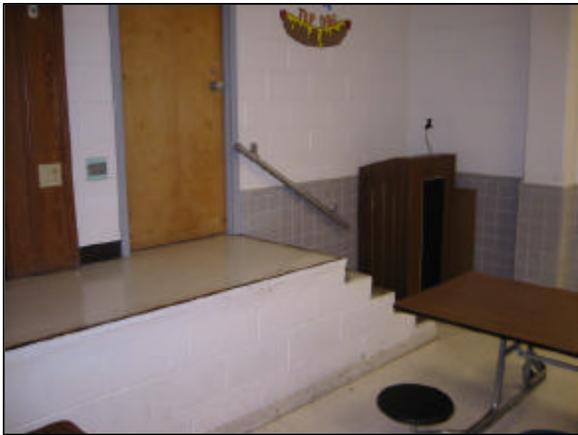
**Photo 7: ADA Non-compliant Stair to Stage**

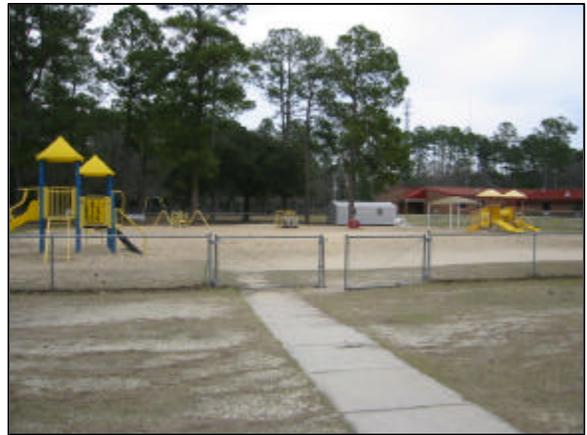
**Photo 8: ADA Non-compliant Play Area**
