# DDESS Facility Transfer Study Facility Condition Report (Final)

## Quantico Marine Base, Virginia

December 10, 2003

QUANTICO SCHOOLS  
QUANTICO MARINE BASE, VIRGINIA  
PROPERTY CONDITION REPORT

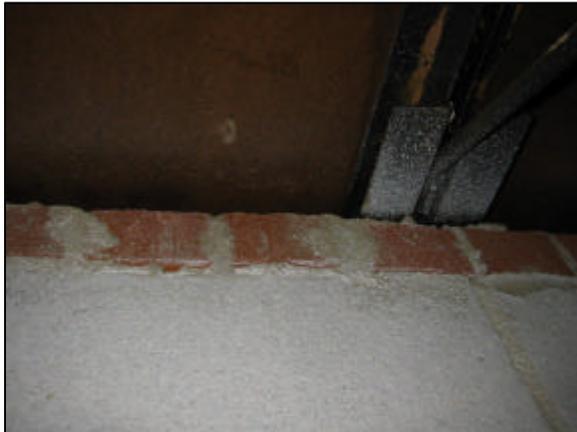
**Fire Rated Wall Requiring Sealing Between Top of Wall and Roof Deck**

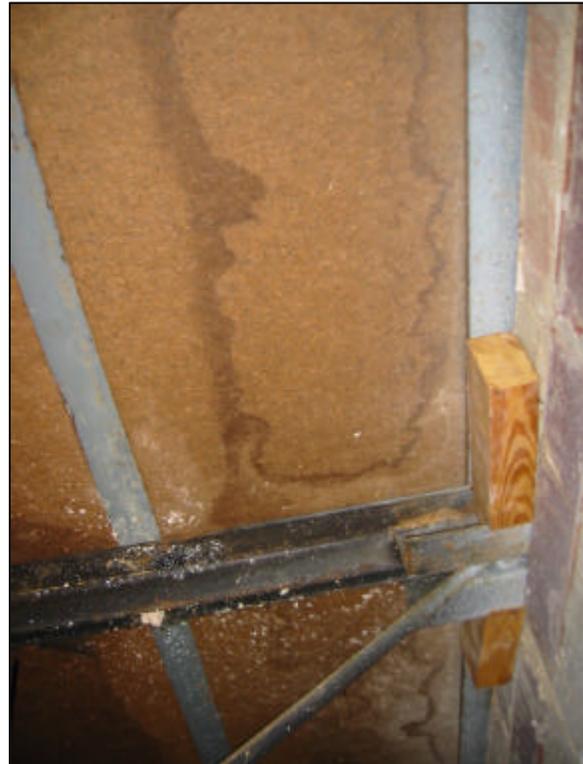
**Damaged Deck due to Moisture Intrusion**

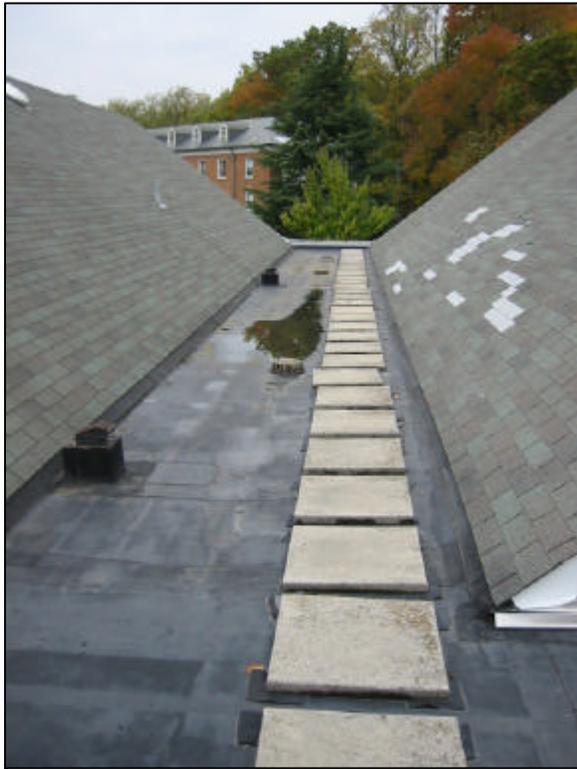
**Damaged Roof**

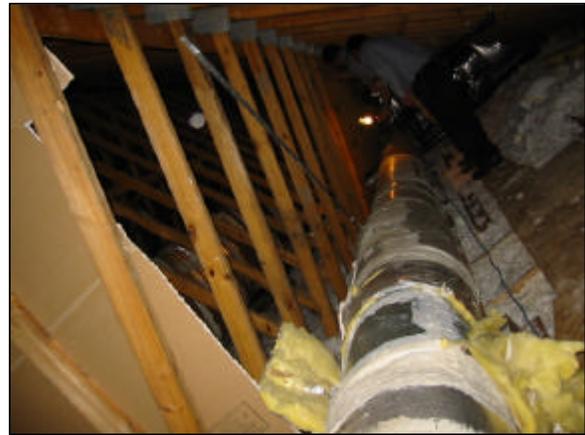
**Damaged Attic Fire Separation Wall**

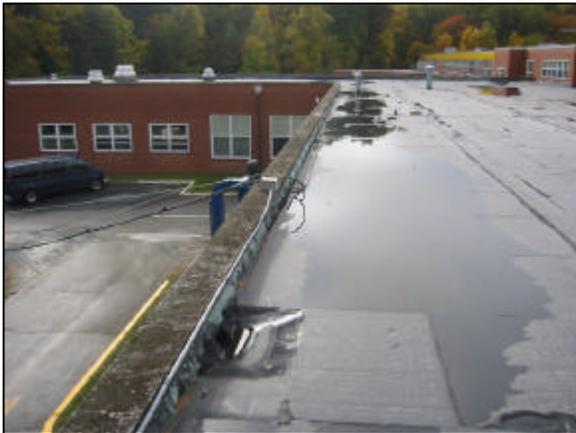
**Roof Drainage Problems**

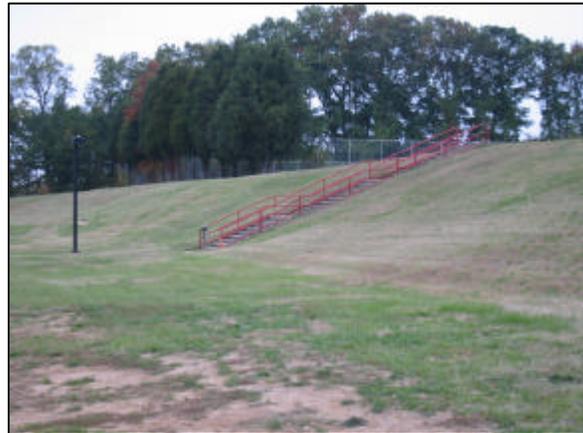
**Stairway to Play Fields in ADA Noncompliance**

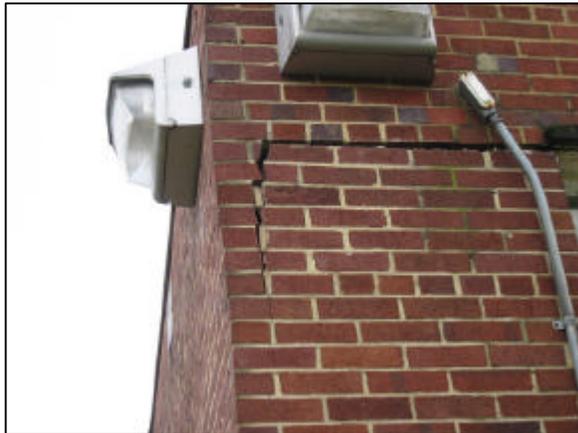
**Damaged Masonry due to Foundation Settlement**

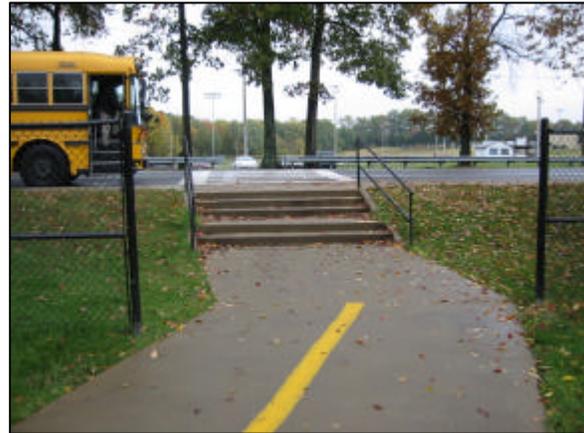
**Stairway to Main Entrance Walkway in ADA Noncompliance**

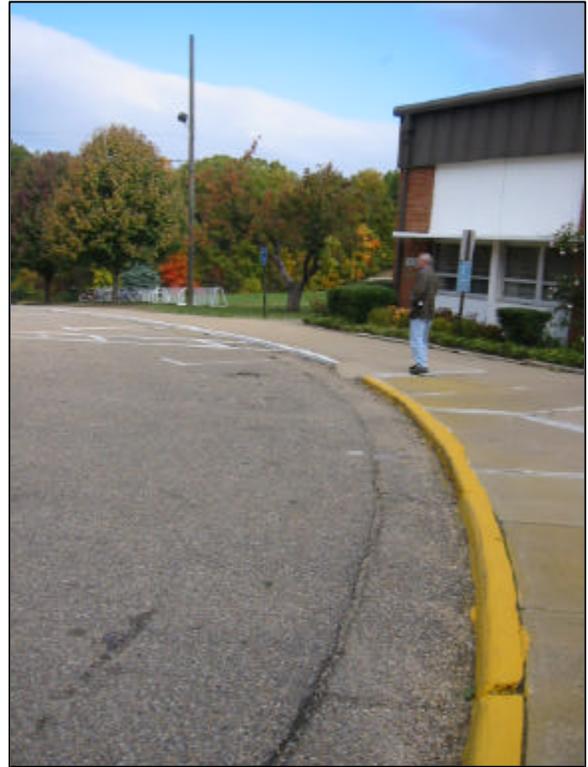
**Photo 2 – Damaged Paving and Walkways**

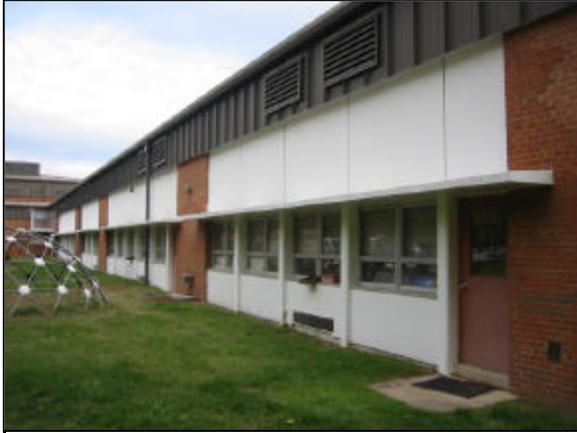
**Photo 5 – Exterior Showing Classroom  
Emergency Exiting**

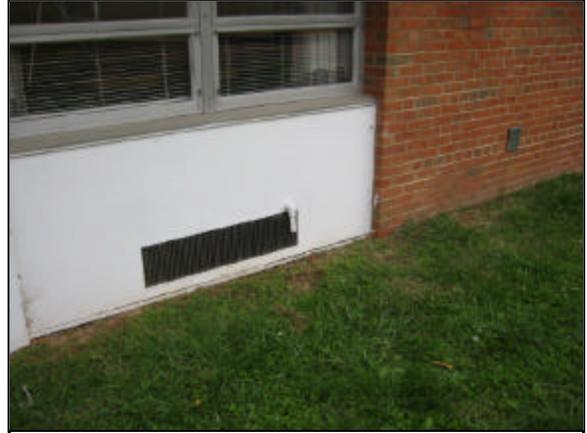
**Photo 6 – Damaged Stucco Wall**

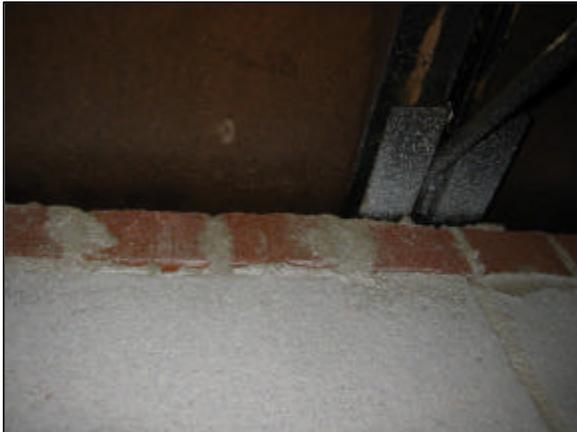
**Photo 7 – Fire Rated Wall Requiring  
Sealing Between Top of Wall and Roof  
Deck**

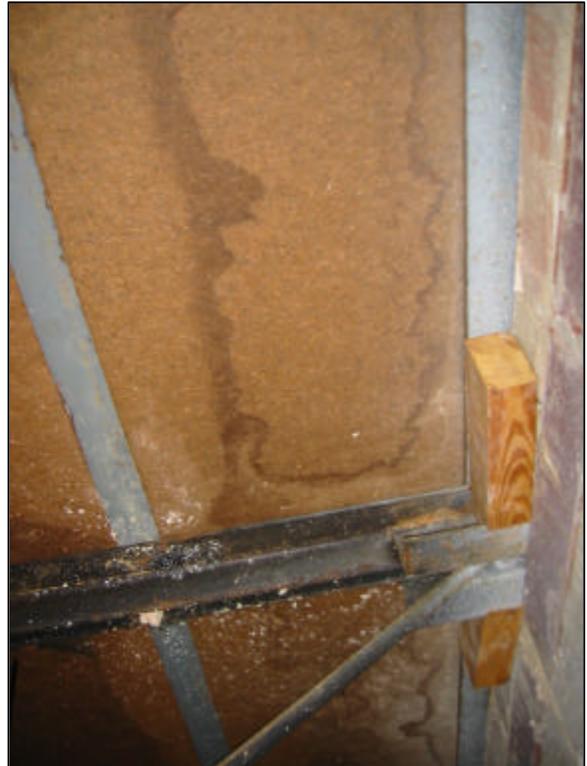
**Photo 8 – Damaged Deck due to Moisture  
Intrusion**

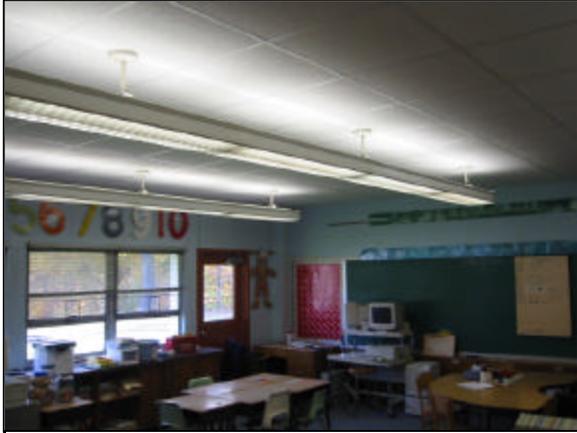
**Photo 9 – Classroom with Deteriorating Pendant Light Fixtures**

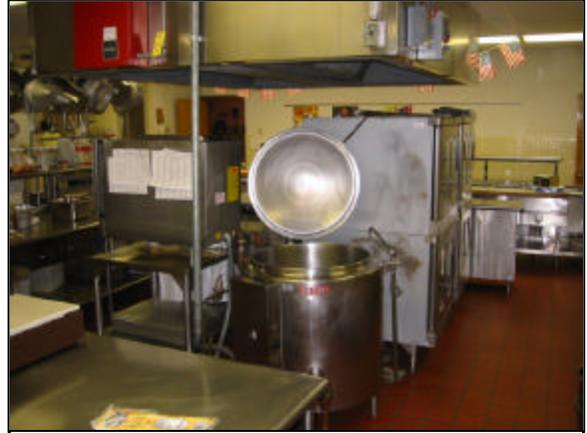
**Photo 10 – Kitchen Hood in NFPA Noncompliance**

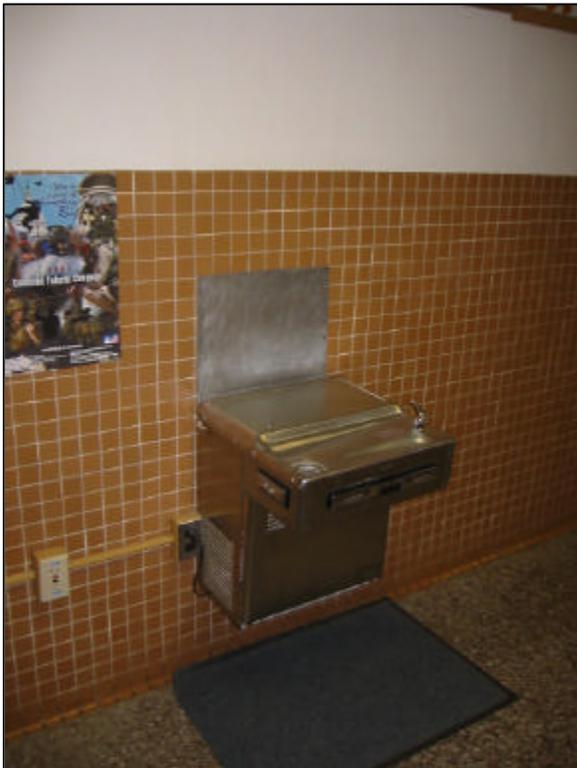
**Photo 11 – Drinking Fountain in ADA Noncompliance**

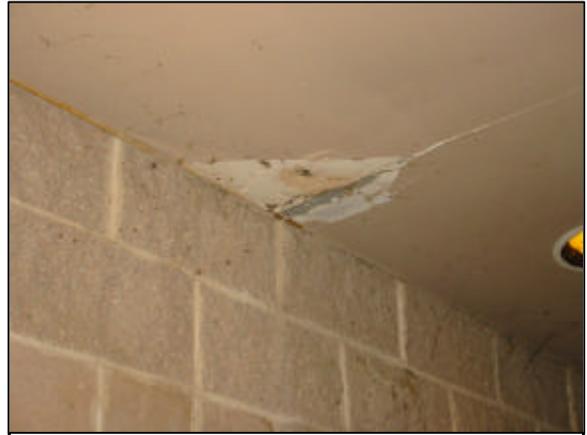
**Photo 2 – Damaged Soffit**

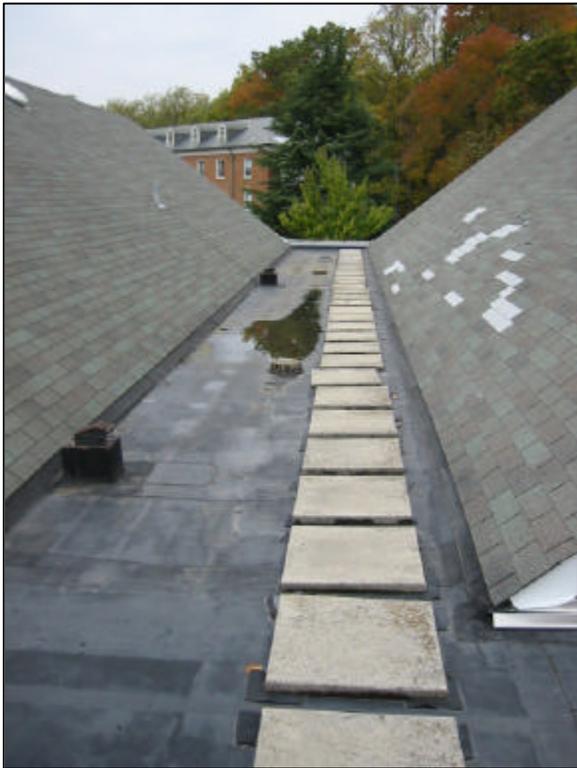
**Photo 3 – Damaged Roof**

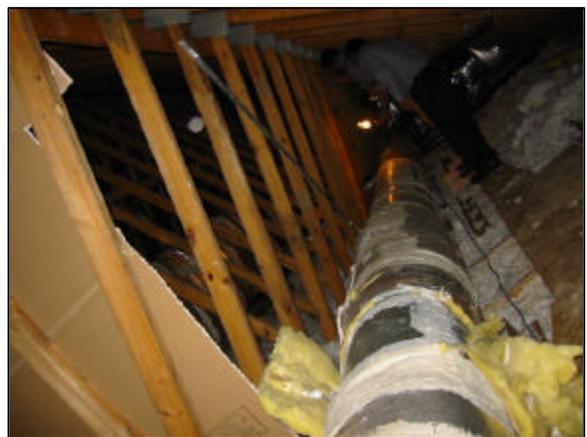
**Photo 4 – Damaged Attic Fire Separation Wall**

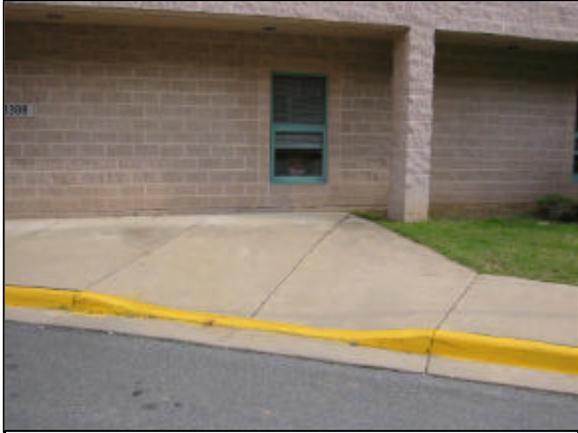
**Photo 5 – Curb Cut in ADA Noncompliance**

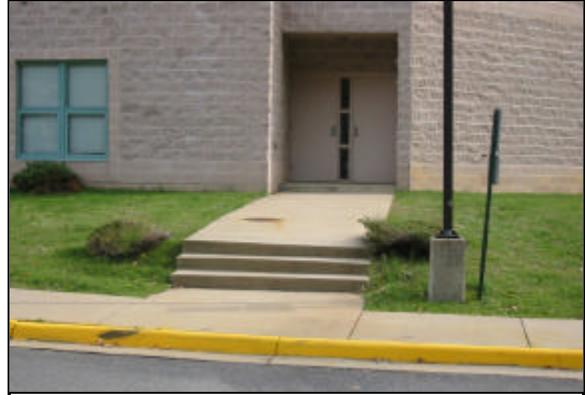
**Photo 6 – Exit in ADA Noncompliance**

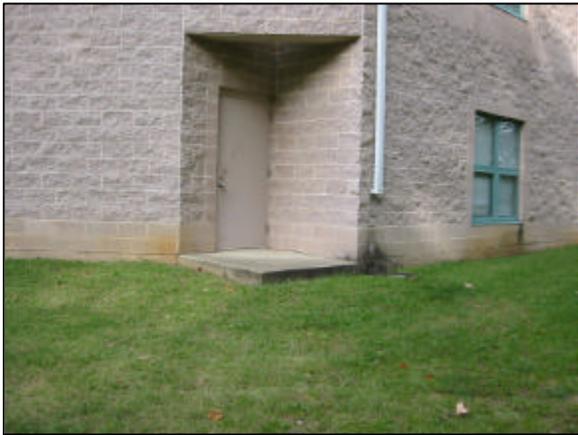
**Photo 7 – Exit in ADA Noncompliance**

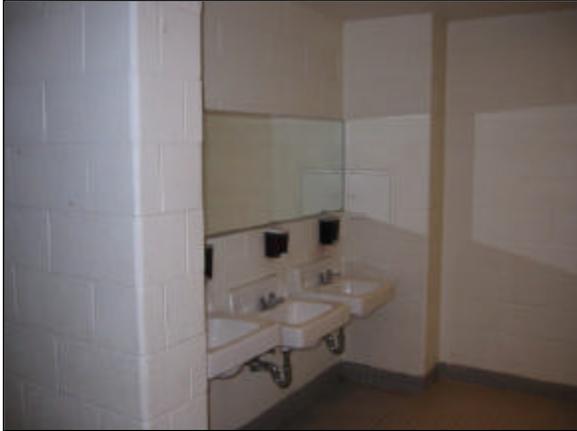
**Photo 9 – Toilet Fixtures in ADA Noncompliance**

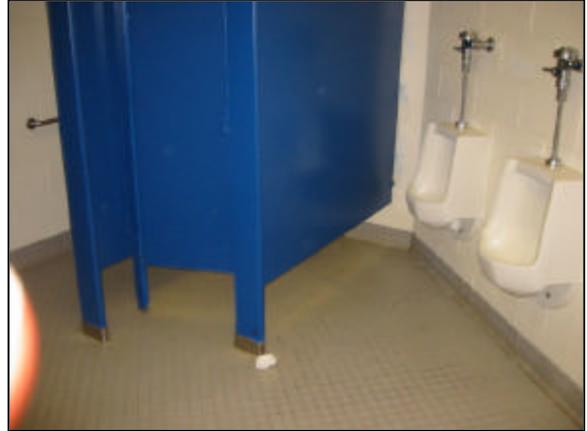
**Photo 10 – Toilet Fixtures in ADA Noncompliance**

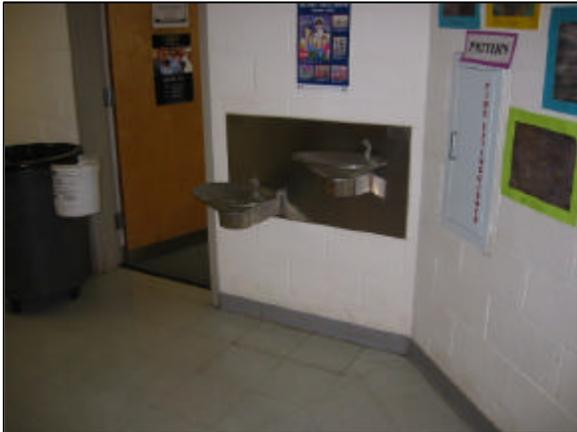
**Photo 11 – Drinking Fountains in ADA Noncompliance**

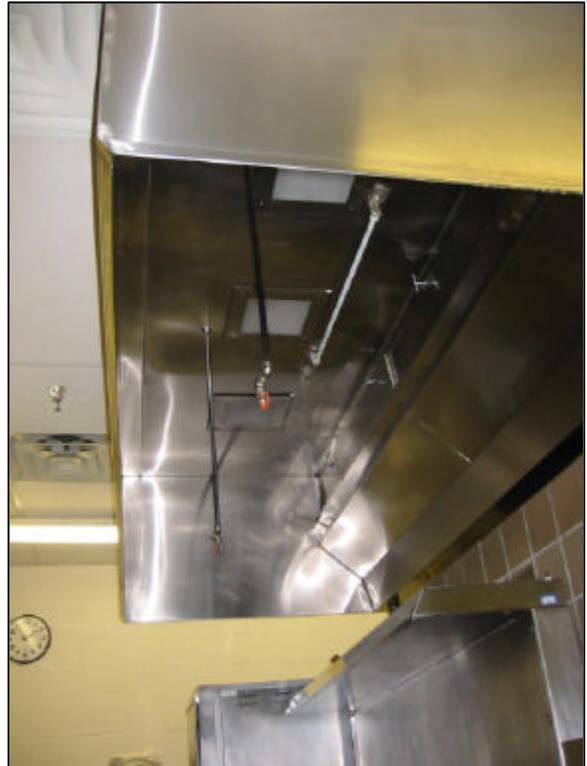
**Photo 12 – Kitchen Hood in Noncompliance**

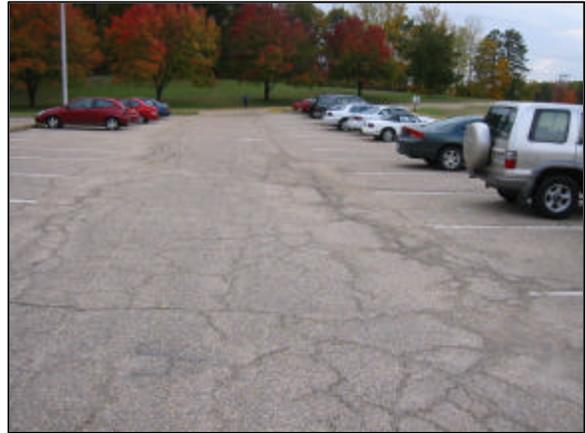
**Photo 2 – Deteriorating Parking Paving**

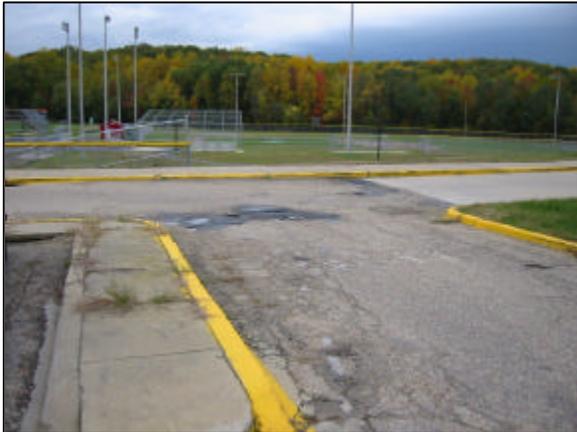
**Photo 3 – Damaged Roadway Paving and Play Fields**

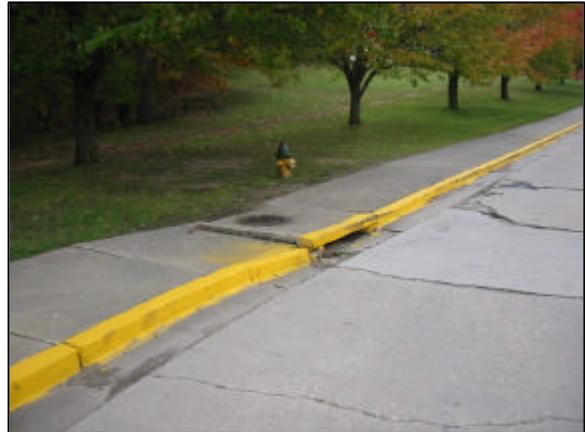
**Photo 4 – Damaged Walkway and Paving**

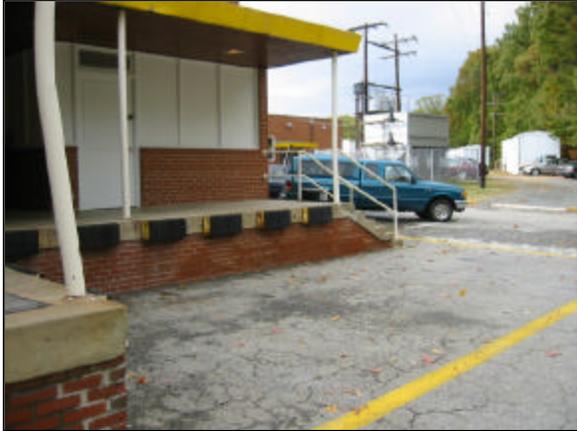
**Photo 5 – Loading Area with Deteriorating Paving and Unsafe Overhead Power Service**

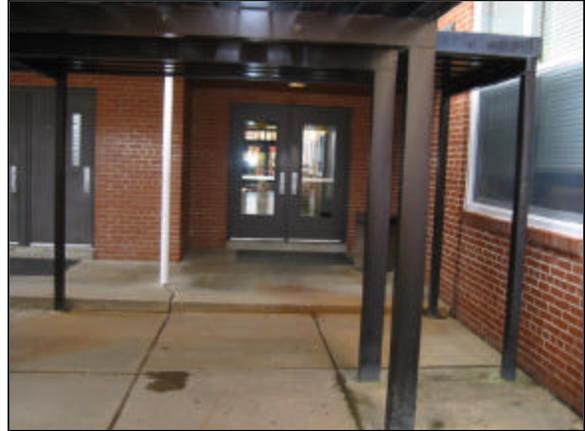
**Photo 6 – Auxiliary Exit Requiring ADA Accessibility Compliance**

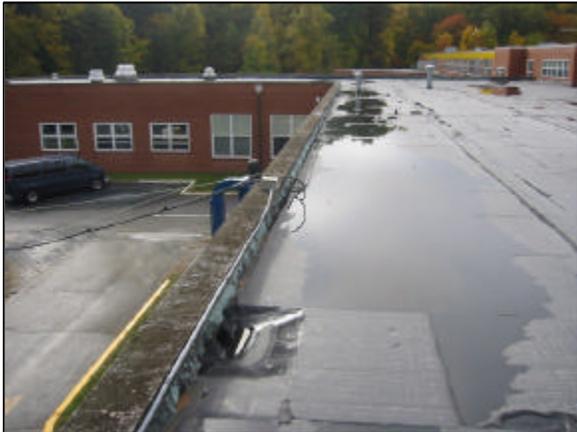
**Photo 7 – Roof Drainage Problems**

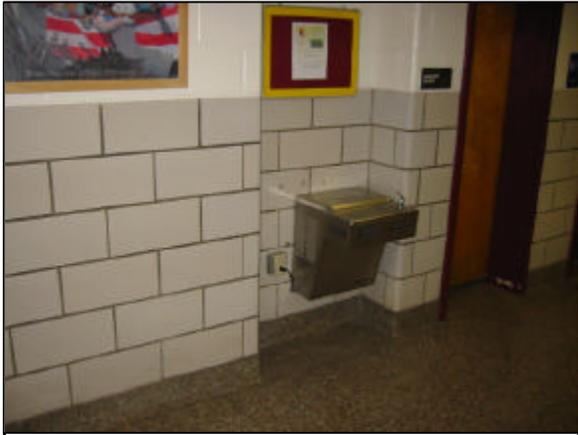
**Photo 9 – Drinking Fountain in ADA Noncompliance**

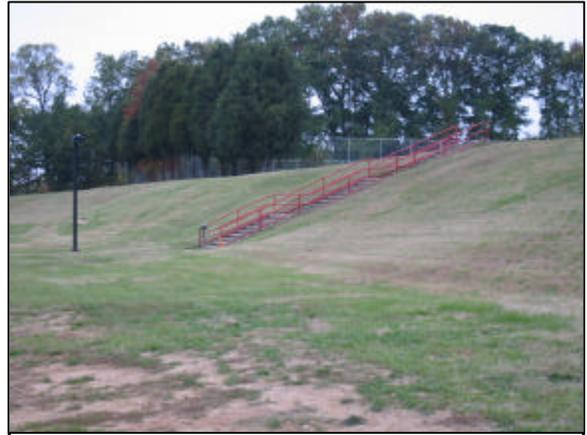
**Photo 10 – Stairway to Play Fields in ADA Noncompliance**

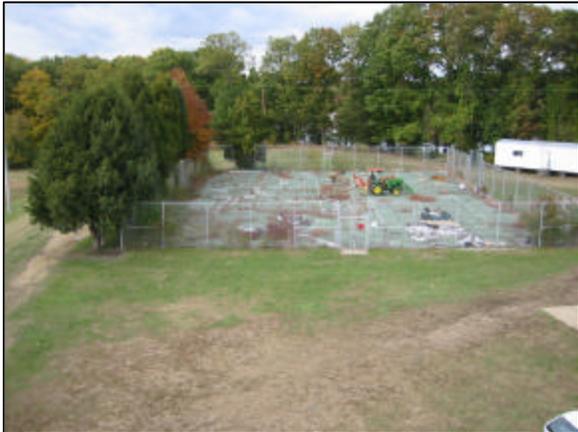
**Photo 11 – Damaged Tennis Courts**

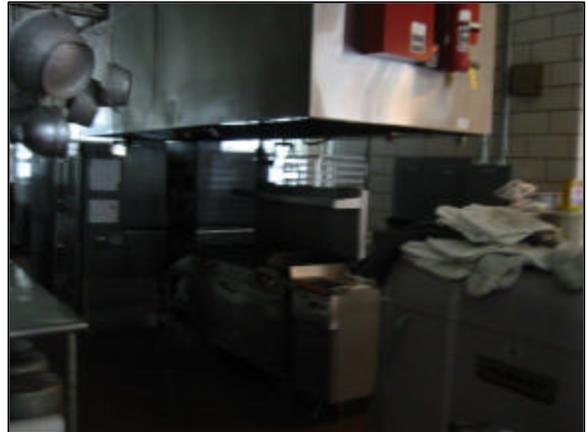
**Photo 12 – Kitchen Hood in Code Noncompliance**

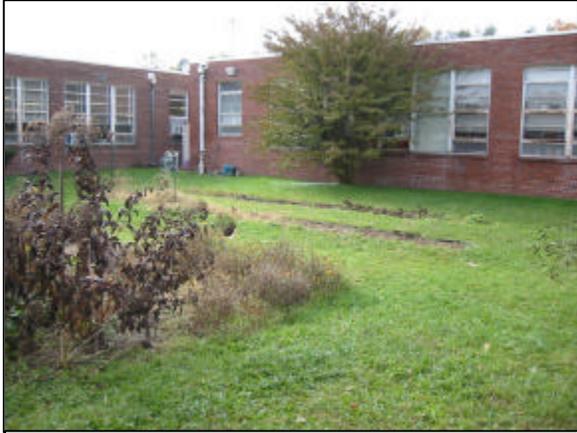
**Photo 1 – Courtyard Drainage Problems**

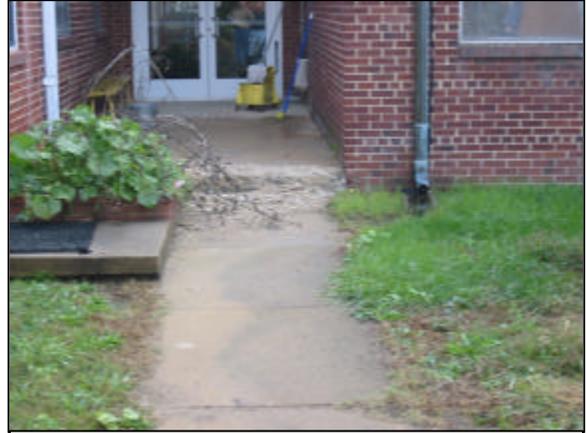
**Photo 2 – Courtyard Exit with Deteriorated Concrete Porch**

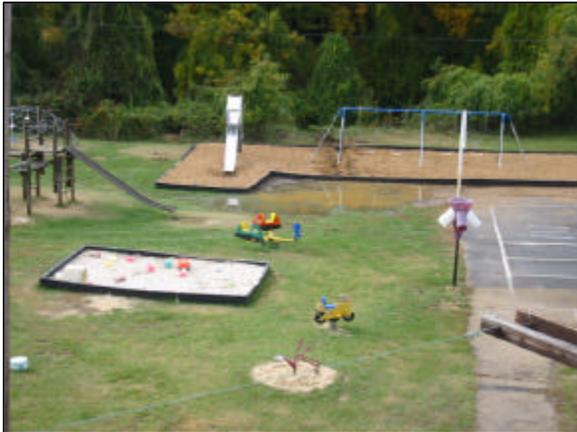
**Photo 3 – Play Area Drainage Problems**

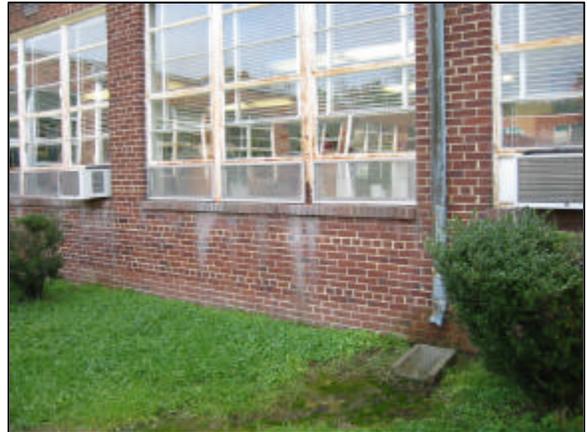
**Photo 4 – Deteriorated Courtyard Windows**

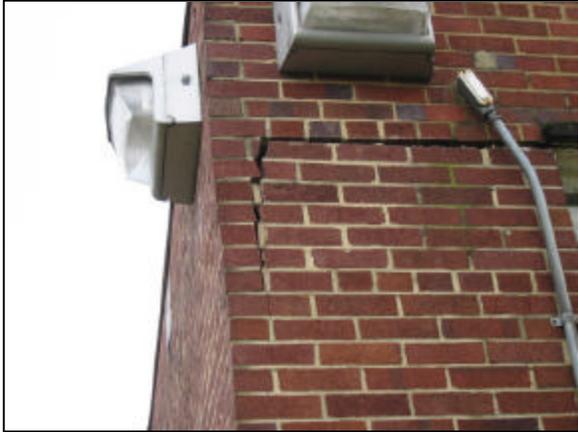
**Photo 5 – Damaged Masonry due to Foundation Settlement**

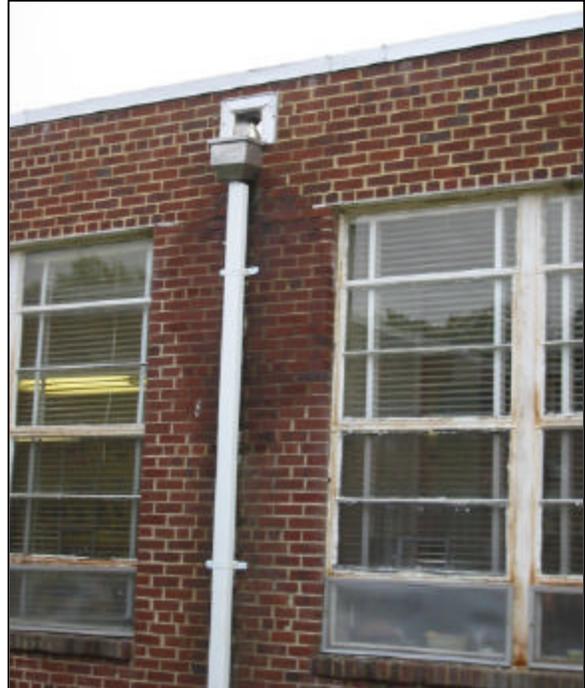
**Photo 6 – Damaged Downspout/Moisture Problem**

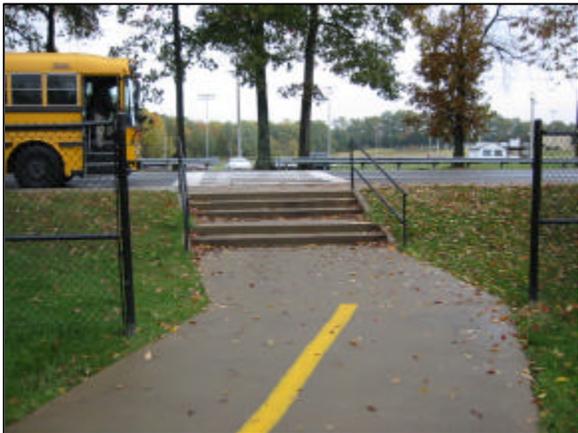
**Photo 7 – Stairway to Main Entrance Walkway in ADA Noncompliance**

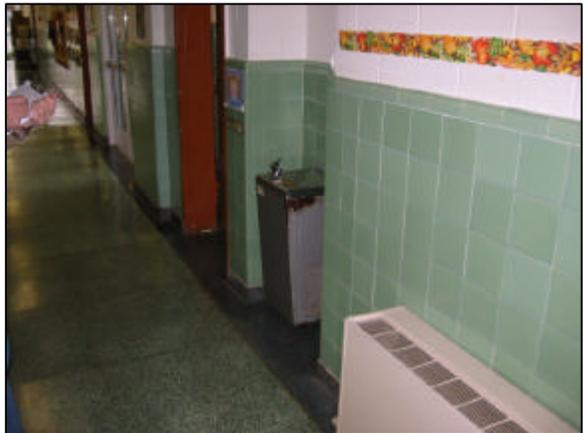
**Photo 8 – Drinking Fountain in ADA Noncompliance**

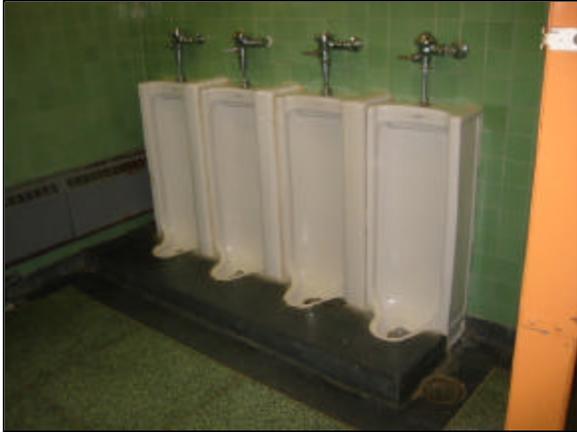
**Photo 9 – Toilet in ADA Noncompliance**

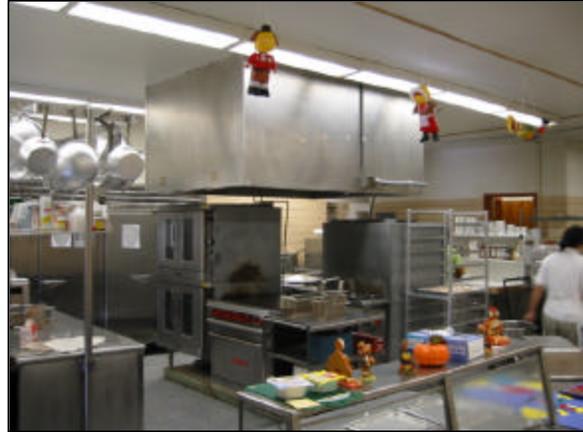
**Photo 10 – Kitchen Hood, NFPA Noncompliance**

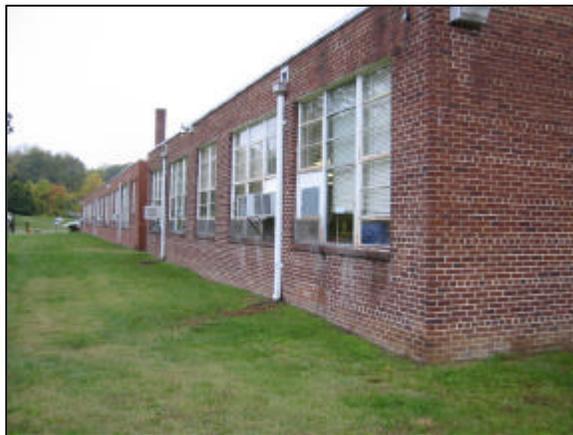
**Photo 11 – Exterior Window Air Conditioning Units, ASHRAE Noncompliance. Window Sealant is ACM.**
