# DDESS Facility Transfer Study Facility Condition Report (Final)

## West Point Schools, New York

December 10, 2003

WEST POINT SCHOOLS  
WEST POINT, NEW YORK  
PROPERTY CONDITION REPORT

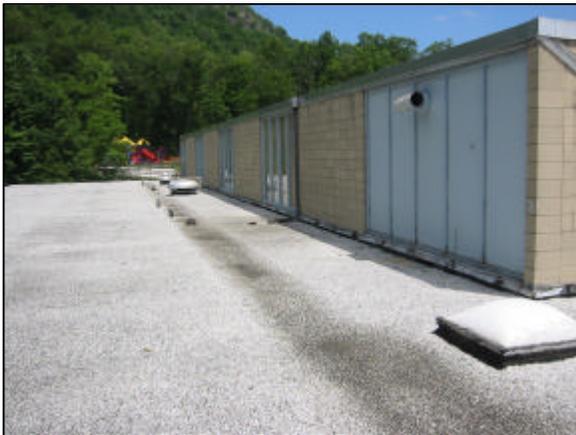
**Roof in Fair to Poor Condition**

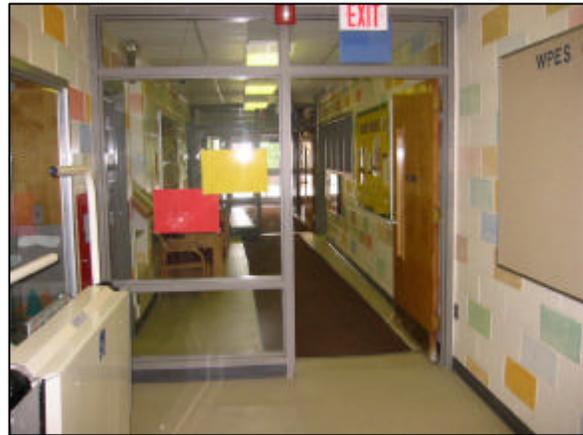
**Non-rated Glass in Exit Corridor**

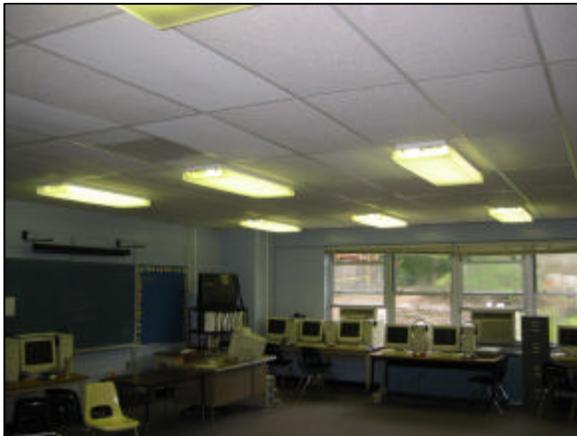
**Poor Lighting**

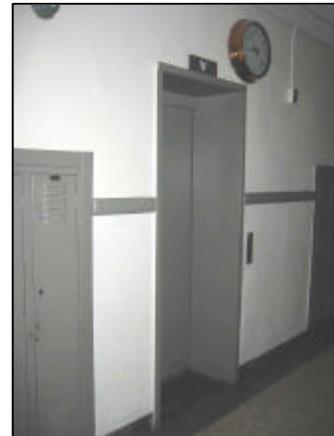
**Non Life Safety Elevator**

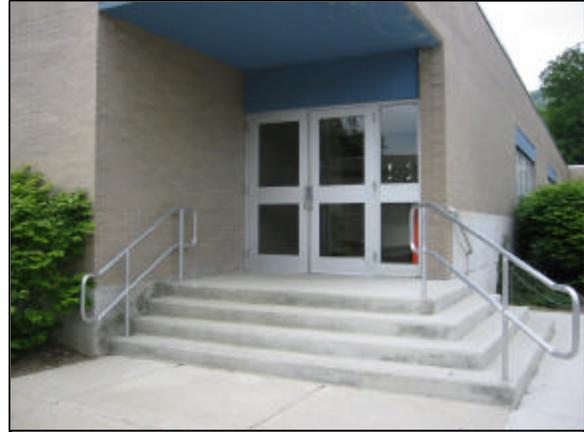
**Photo 2: Non-accessible Entrance**

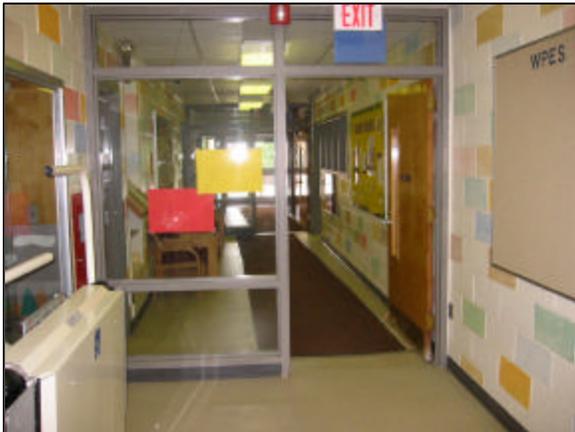
**Photo 3: Non-rated Glass in Corridor**

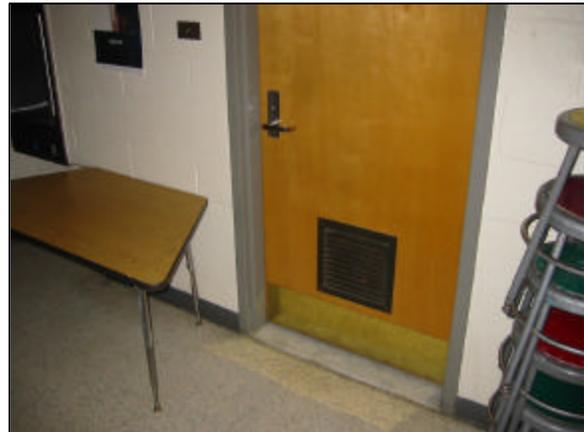
**Photo 4: Louvered Door, Life Safety**

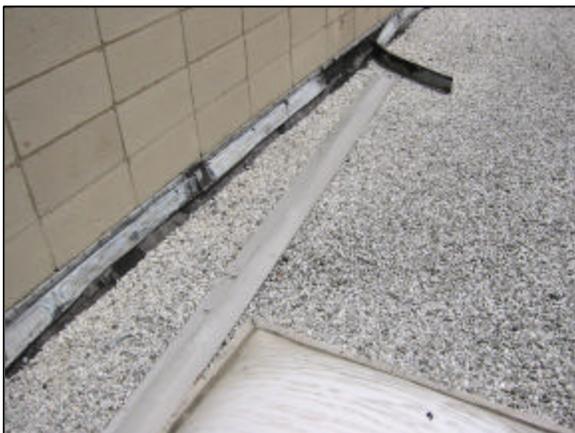
**Photo 5: Roof Flashing Damage**

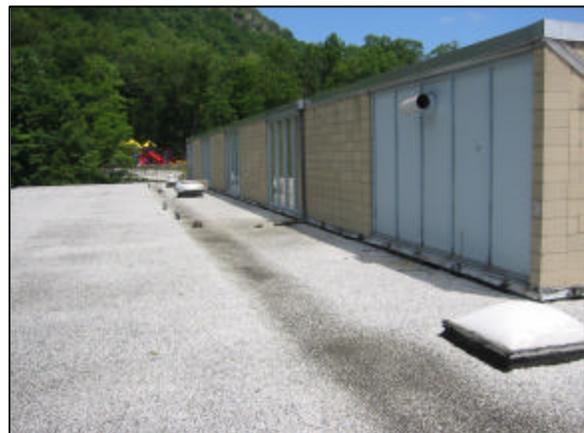
3.3.4 Roofing
X	X	Low slope gravel surface built-up roofing is located on the original building and is in poor condition. Minor leaks are evident. Corrective action is required immediately to repair leaks that staff feels could cause mold growth. Long-term action includes roof replacement.
	X	Low slope ballasted EPDM roofing is located on the 1987 classroom addition and is in poor condition. Minor leaks are evident. Corrective action is required.
X		Flashing, coping, fascia, gutters and downspouts are pre-finished metal in good condition. Corrective action is required.
		<b>3.4 Interior Elements</b>

**Photo 6: Roof in Fair to Poor Condition**

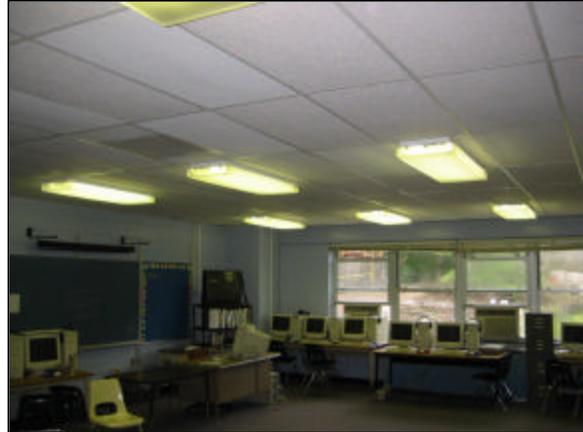
**Photo 2: Poor Lighting**

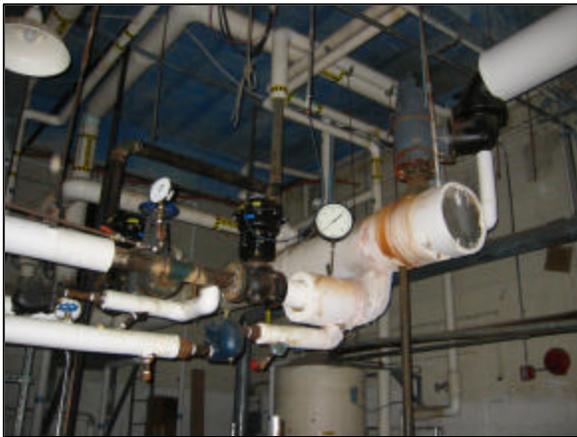
**Photo 3: Replace Steam Piping**

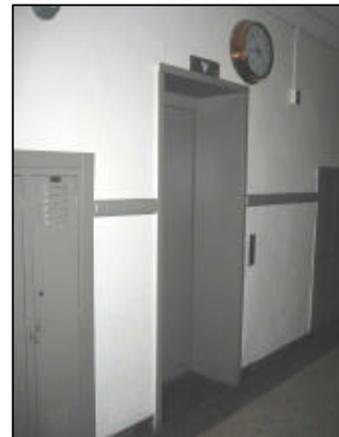
**Photo 4: Non Life Safety Elevator**

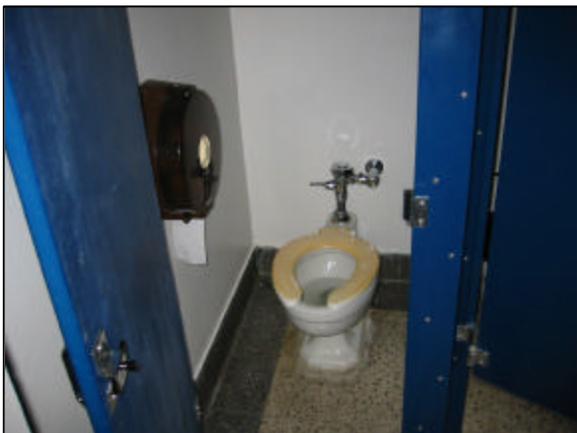
**Photo 5: Non-compliant Toilet**

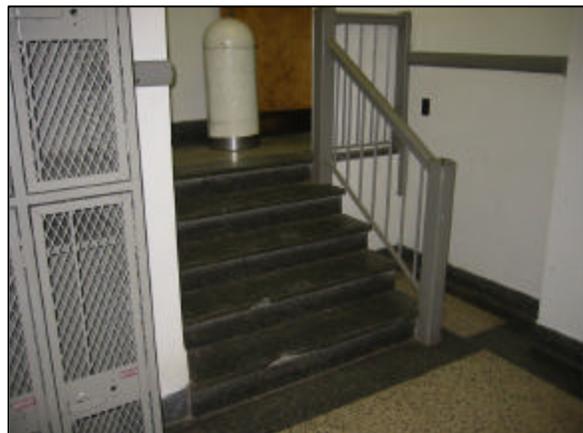
**Photo 6: No Lift at Corridor Transition**
