DDESS Facility Transfer Study Facility Condition Report (Final)

December 10, 2003

PSC Project # 03811102

FORT BRAGG SCHOOLS
FORT BRAGG, NORTH CAROLINA
PROPERTY CONDITION REPORT

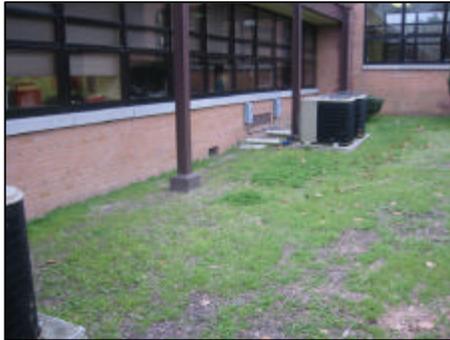
Drainage Problem

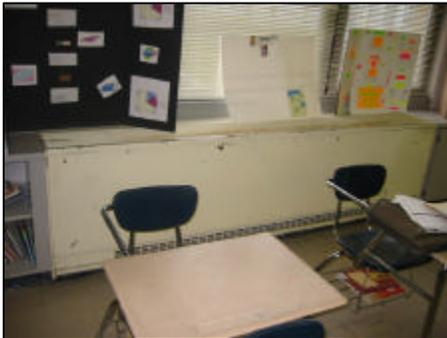
Old Fan Coil Units

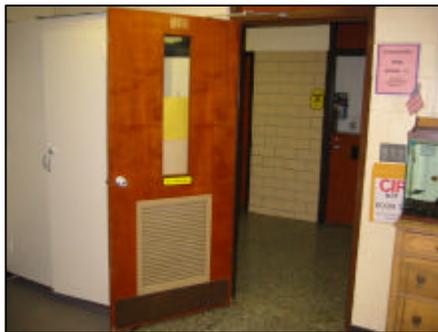
ADA Non-compliant Door, Signage and Life Safety Code Non-compliant Louvers

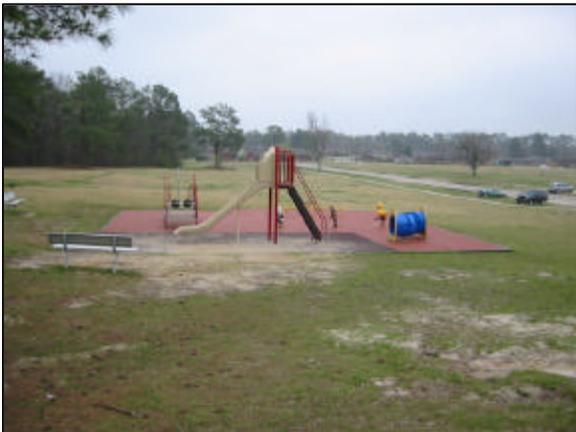
Photo 7: ADA Non-compliant Play Areas
